NEBRASKA MAIN STREET NETWORK

# DESIGN CASE STUDY

MOYER'S BUILDING | PITZER DIGITAL

Neligh, Nebraska

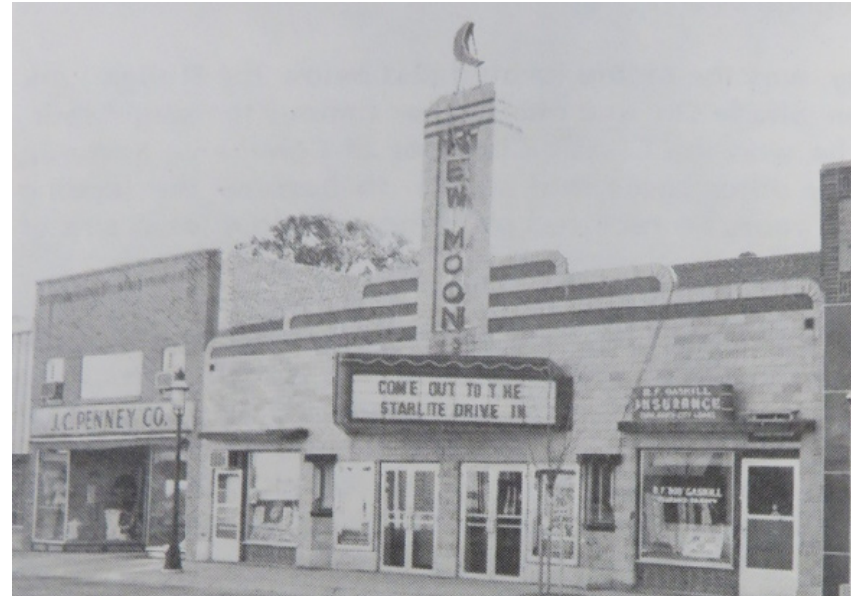
The Moyers building has a great deal of extant original fabric. The store front at street level is original and the brickwork is original and in fair to good condition. The biggest change on the façade of the building is the addition of the hipped roof canopy (*image at right: Building on the right, as it appeared c. 1970*).

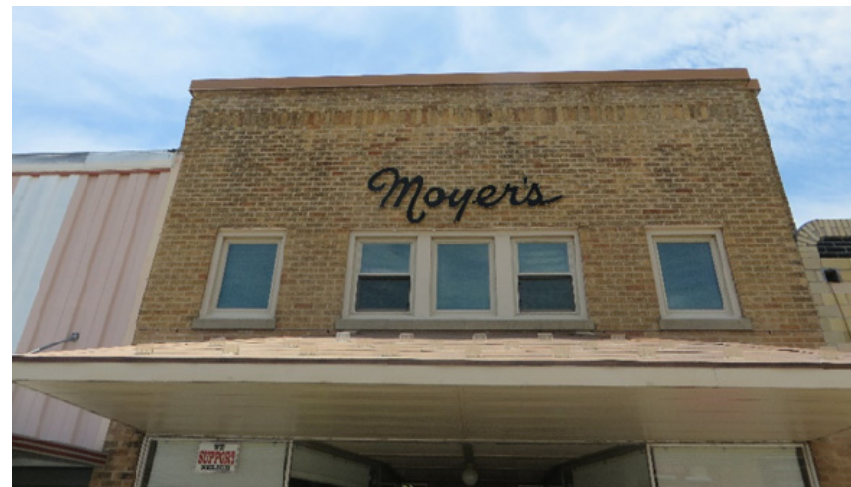
Above the storefront, the wall is yellow brick, original to the construction of the building, with a simple soldier course of brick in the same color at the top that denotes a cornice. The brick is in good condition (*image at right: brickwork of the wall above the storefront*).

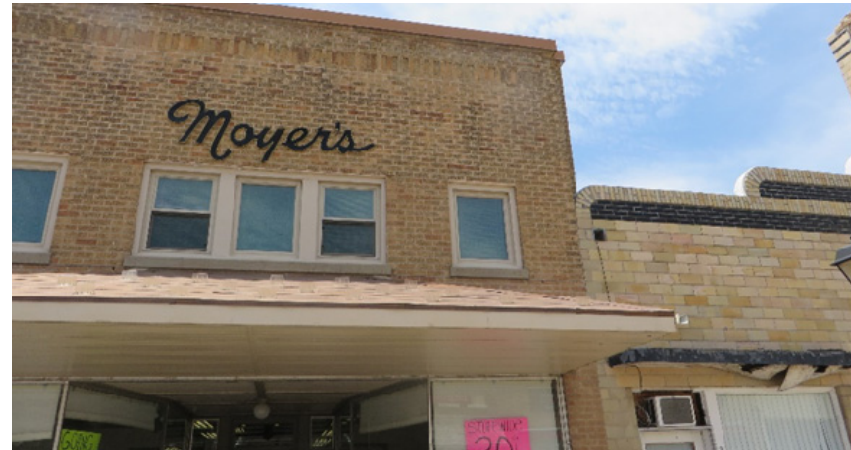
The windows on the second level have been replaced at some point in the past. The originals were one-over-one, and have been replaced with casement. However, the openings have not been altered so the window pattern is original (*image at right: windows at the sides were originally one-over-one single hung windows, the same as the windows in the center flanking the middle casement*).

- Not a critical issue aesthetically speaking, but if windows are ever to need replacement, it is recommended that single or double hung one-over-one windows replace the existing.

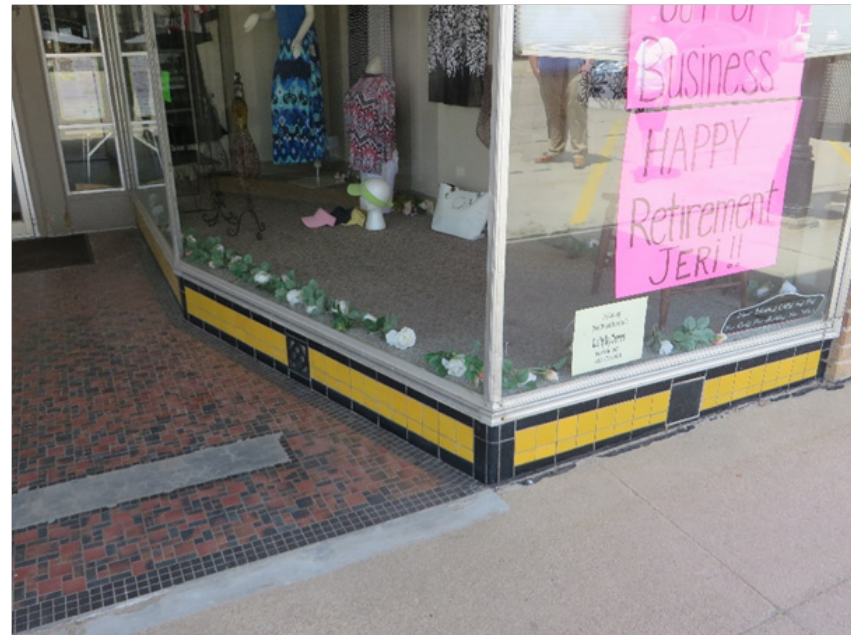
The configuration of the storefront with the recessed entry is original. The material of the storefront is also original, including the glass frames, tile section of wall under the windows, and the tile floor outside the front door within the entry recess (*image at right: storefront showing the original window frames and tile work*). Some tiles are missing, and the front door has been replaced with an aluminum glazed door at some point in the distant past.

- Replace missing tile.

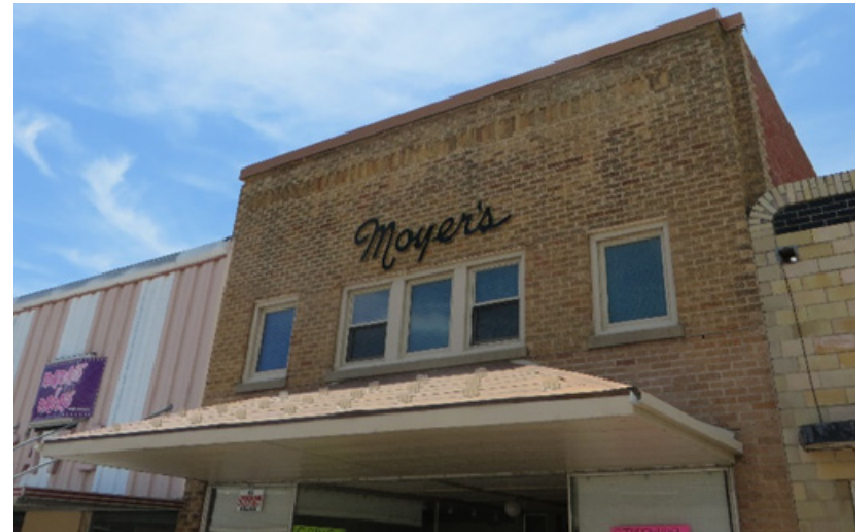
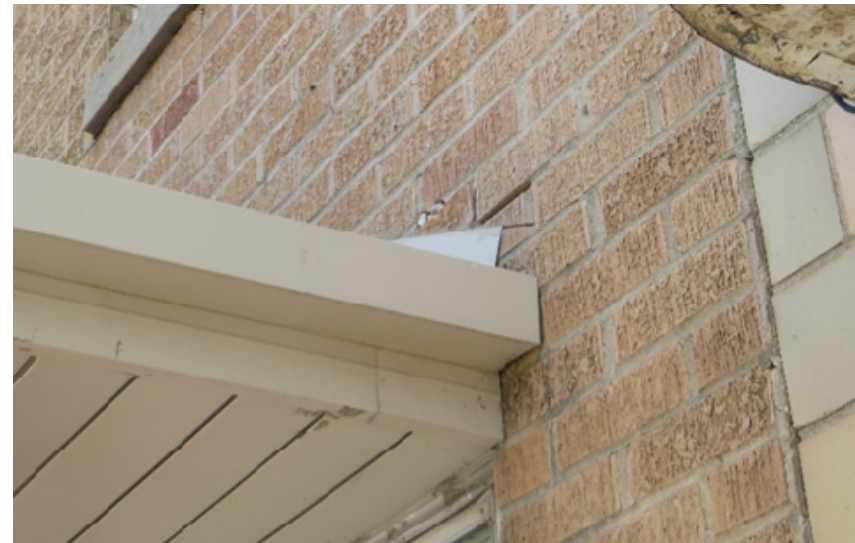
The period image on page 3 seems to suggest an awning was originally on the building, and holes in the brick wall above the storefront seem to suggest there was a retractable awning. The existing wood shingled hipped roof awning is not appropriate for this building (*image at upper right: storefront showing the existing awning*). It is apparent that the flashing for the existing awning is cut diagonally into the brick wall (*image at lower right: end of cut line for flashing of hipped awning roof*).

- To be period correct and more appropriate to the architecture of the building, the existing awning should be removed in its entirety. A possible replacement would be to install a fixed canvas awning or a retractable canvas awning that would cover the incised diagonal cut in the brick when the canopy is removed.

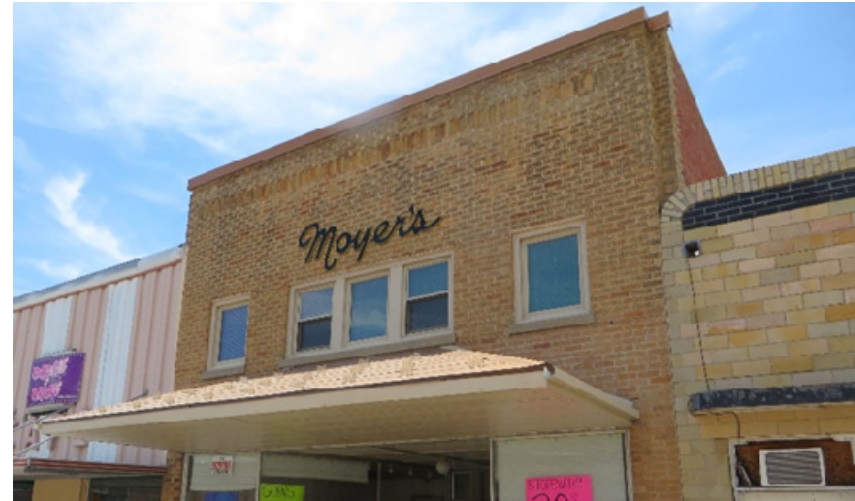
The Moyers sign, while prominent, is not in the traditional location.

- The sign should be removed from this location and be a part of the awning and professionally designed laser cut vinyl on the storefront glass.
