Peck Properties LLC

Cy North 614 Grant Avenue York, NE 68467 Fax: 402.323.7349 **Main Street**

Project Code: Y R K 0 8 0 1 01 JUN 2009

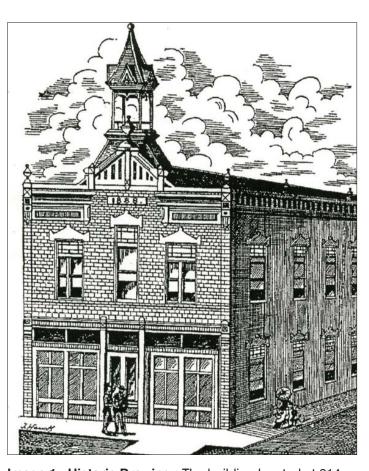
Image 1. Historic Drawing. The building located at 614 Grant Avenue, built in 1888, originally served as city hall for York, Nebraska. The building was a two-story structure in its original configuration.

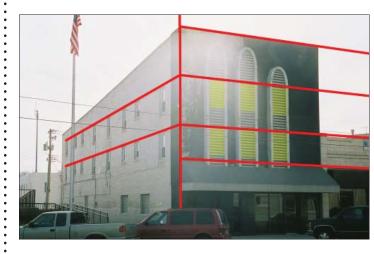
Image 4. Front Façade Window Locations. The locations of the second and third story windows were derived by projecting the lintel lines of the windows on the north wall around the northwest corner of the building and across the front façade. The presumed locations of the windows behind the louvers are marked with yellow shading in the photograph.

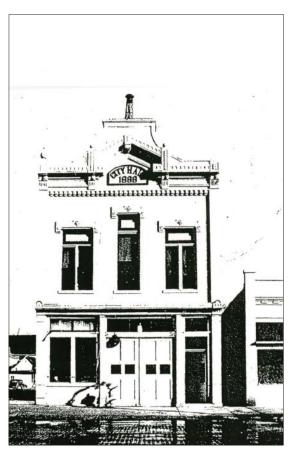
Image 2. Historic Photograph. In later years the building was used as a fire hall. A large garage door to accommodate fire fighting equipment was added, thereby significantly altering the first story front façade of the building. The original second story had an unusually high floor-to-ceiling dimension.

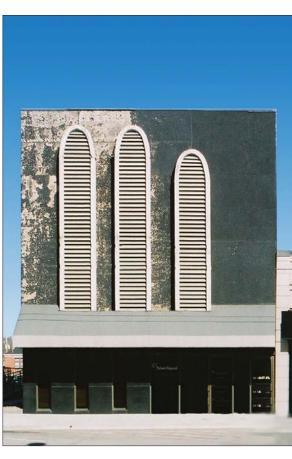
Image 3. Existing Condition. In more recent years, the second story was vertically divided to encompass a third story in the building. The building façade was dramatically altered by the addition of a false front, consisting of butt-joined plywood sheets with stone aggregate applied to the surface. Now deteriorating badly, this false front covers the entire second and third stories of the building and includes three arched elements, constructed with wood frames and louvers that cover the second and third story windows.

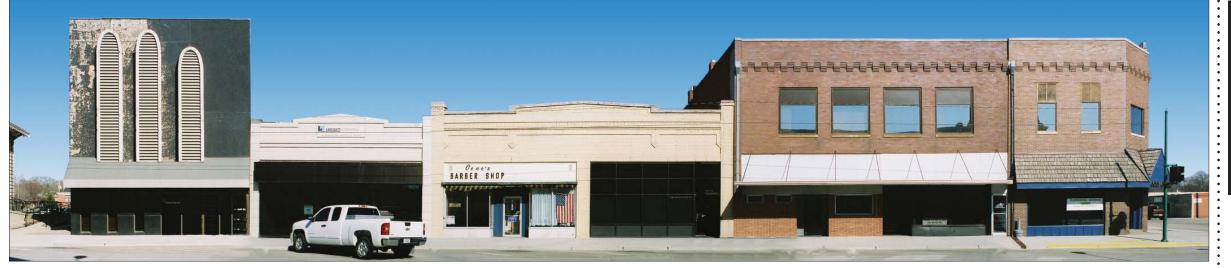
Image 7. Existing Streetscape. The subject building, at left in the photograph, was remodeled some years ago to include reconfiguration of the original second story into a lower-height second story and new third story, with rental housing on both floors. The original tall second story window openings were infilled with masonry, and smaller double hung windows were installed in the reconfigured second and third stories. While the second and third story windows are likely aligned vertically, they may be unevenly spaced (but not too noticeably) in the horizontal dimension on the façade. The remodeling included the addition of an enclosed stairway from the street to the second story on the south side of the building. The false front with three arched, louvered, elements was built full-height across the building's entire front façade, including a wing wall above the enclosed stairway on the south side of the building (see Images 5 and 6).
