# NEBRASKA MAIN STREET NETWORK Design Case Studies

Downtown Schuyler, Nebraska  
Fall 2020

# Case Study #1

Burrito House & Adjacent Vacant Building to the East  
309 East 12th Street

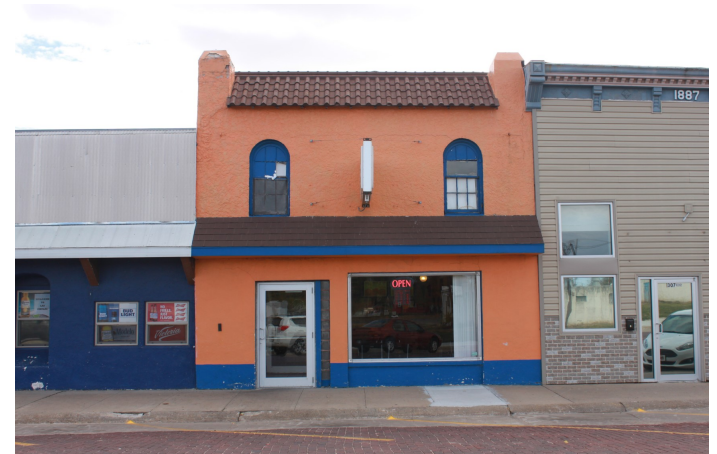
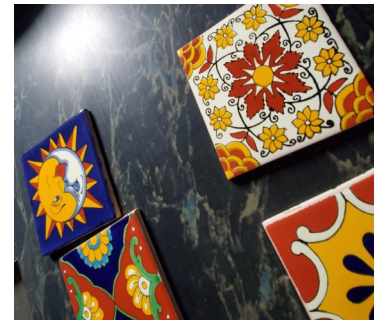
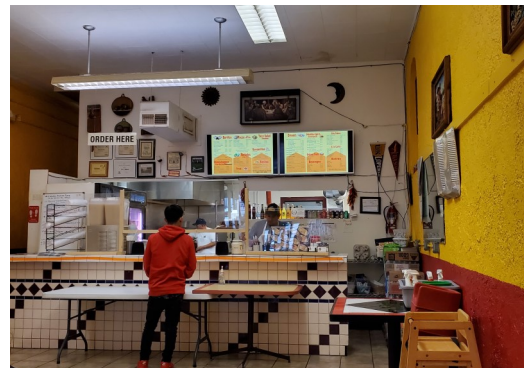
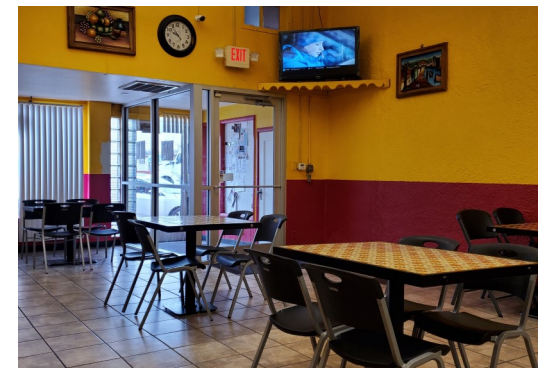
The Burrito House restaurant is considered a contributing resource in the Schuyler Downtown Historic District National Register nomination. The building was constructed c. 1920 for the Avalon Theater. It is a 1 ½ building with stucco cladding the exterior, two arched windows at the second floor and an angled clay tile parapet between stuccoed pilasters caps the building. Today an angled asphalt-shingle canopy spans the middle of the façade above the storefront.

The main floor houses the restaurant, accessed by a contemporary aluminum pedestrian door next to a large plate glass display window/storefront. The restaurant interior is decorated with bright primary colors. Each tabletop is tiled with Mexican tiles in an array of multi-colored geometric designs. The exterior façade is painted light orange with blue trim.

The exterior appears to be in good to fair condition. However, there are areas where the stucco finish is spalling and bowing slightly. Stucco as a material has been used since ancient times and is still widely used throughout the world. Historically stucco (up until the late 1800s) was primarily lime-based, but with the advent and of Portland cement, the composition of stucco changed to a much harder and more durable material. The same is true for plaster that is often used interchangeably with stucco. Stucco was popular in many revival styles of architecture at the turn and first part of the twentieth century, the period of construction of this property. Stucco was an affordable and readily available material. This is apparent under the first story asphalt shingled canopy where the stucco is crazing. Most stucco deterioration is the result of water infiltration either through the roof, around chimneys, windows or door openings, or ground water wicking through the foundation. These could be caused by ground or foundation settlement, opening a crack; lintel or door frame settlement; insufficient, clogged or leaking gutters and downspouts, biological growth from intrusive vegetation, moisture migration within the walls due to interior condensation and humidity; vapor problems from furnace, bathroom and kitchen vents; or poor site drainage around the foundation. Water or moisture infiltration will cause the wood lath to rot and metal lath and nails to rust which will eventually cause the stucco to lose its bond and pull away. Horizontal surfaces such as the tops of parapet walls or chimneys are particularly vulnerable. An evaluation of the roof, roof drains, and structure of the canopy by a qualified professional will identify any water infiltration or roof repair issues that may be warranted. Repair to the cause of the damage is important to fix, prior to repairing the damaged stucco. Often small hairline cracks can be sealed with a thin slurry of new stucco and painted or white washed. Additional detailed information can be found in the *Preservation Brief 22: The Preservation and Repair of Historic Stucco*. (see resource list at the end of the document)

The second floor arched 6/6 windows are an important feature to the façade. If possible consider retention of the existing historic windows. If the historic windows are deteriorated beyond repair, then replacements in appropriate configuration to match the existing with the arched top and the multi-lights should be considered. Aluminum frame windows are acceptable as well as wood-clad aluminum frame. To preserve and continue to enhance the historic character of the building, vinyl windows should be avoided. Replacement windows do not need to be true divided lights but can have an applied muntin to both the interior and exterior glass pane with interior spacer to give the depth of the historic window. If aluminum clad windows are selected, the overall color scheme of the exterior should be considered, since the window units can be purchased in specific colors.

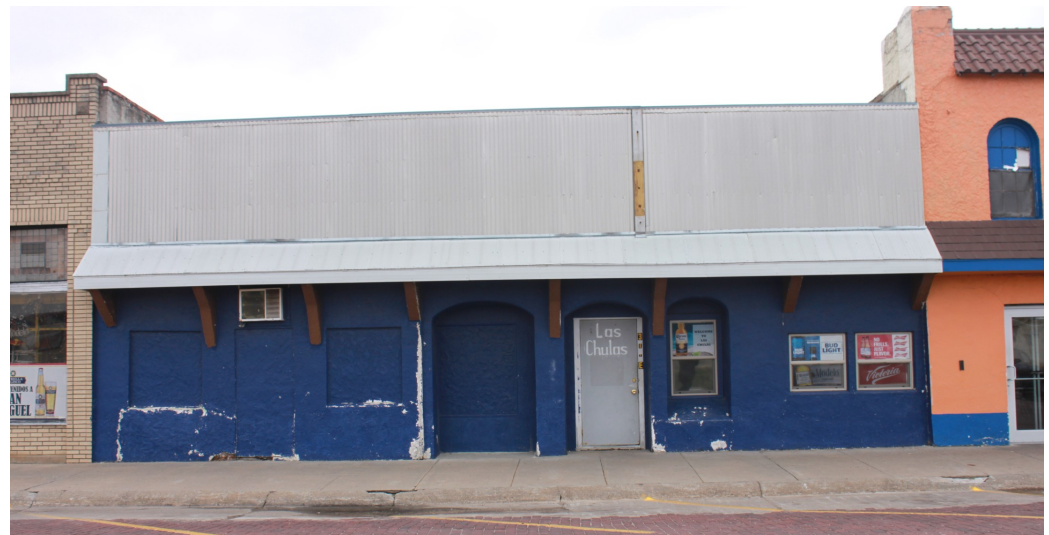
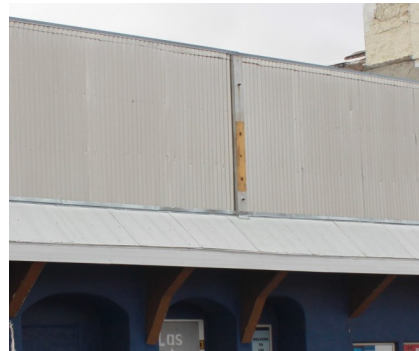
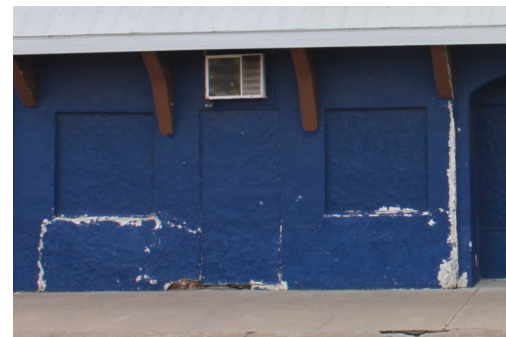
The vacant building located to the east of the Burrito House is a one story, stucco façade with corrugated steel covering the upper portion of the façade. Window and door openings have been infilled on the main elevation, and the building is listed as a non-contributing resource in the downtown historic district.

The lower level is painted dark blue and the full-width canopy is metal with exposed brackets painted brown. This simple façade offers some opportunity to utilize the colorful Mexican tiles in the owner's collection.

Repairs to the main level stucco should be identified and addressed. Refer to the stucco repair information included in the Burrito House recommendations.

Retain the corrugated metal paneling at the parapet wall. The metal adds to the feeling of the restaurant theme and can be incorporated into branding. The possibility of removing the metal paneling is an option, but with the unknown condition of the walls beneath, it may cause more damage to remove it rather than to retain it and work the feature into the branding for the business. Repair the area and put up new slipcover paneling where a sign had been mounted previously.

The former window openings should be restored with new windows. This will help bring people into the restaurant and the transparency to see what is going on inside the building provides an added sense of comfort for the pedestrian. The façade could be painted a light neutral color as shown in the illustration below. To add dimension and color to the elevation, a row or band of decorative tiles could be added across the stucco first story just under the window line. Additionally, a tile mosaic could be added in the segmental arched recessed opening that remains infilled.

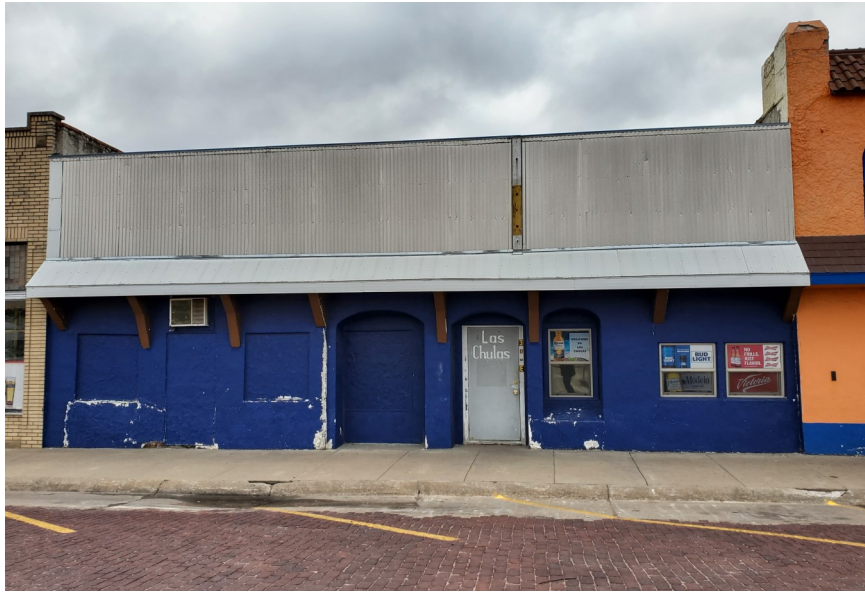
Current Condition

*Flat sign board locations  
for business signage*

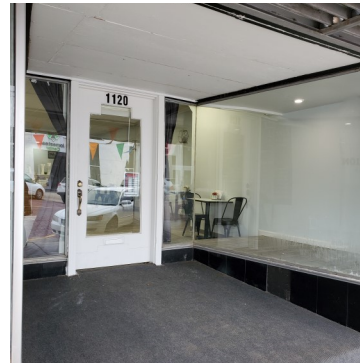
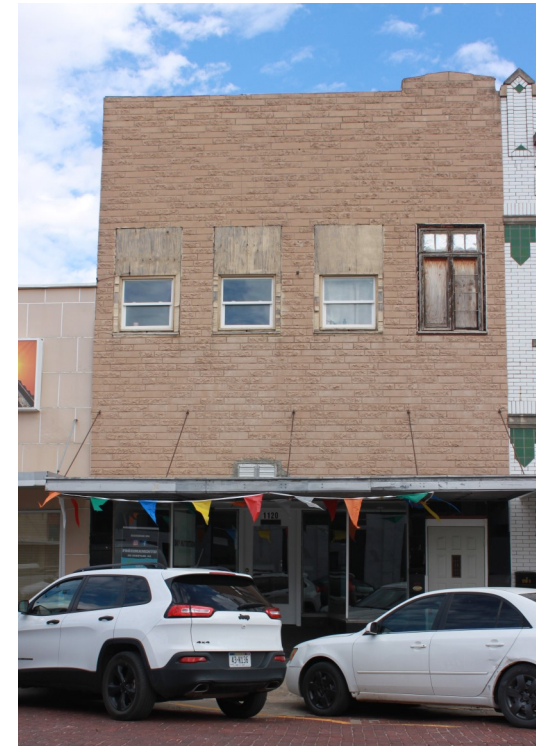
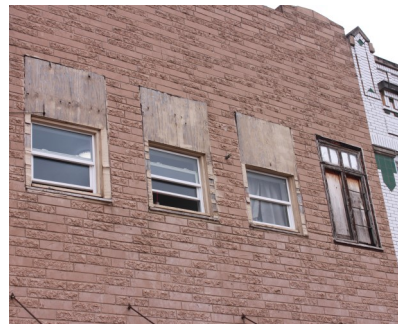
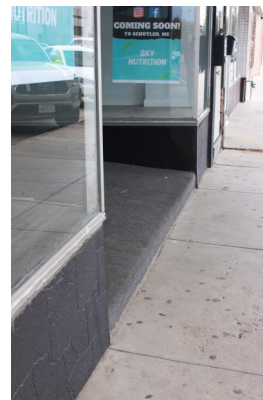
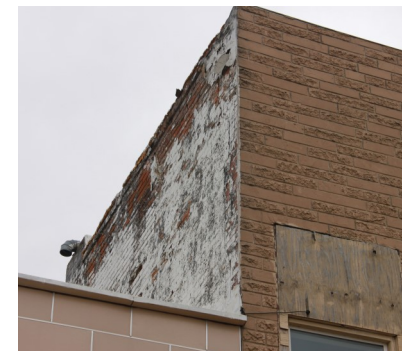
This two-story commercial block was constructed c. 1889 with alterations c. 1950 and c. 1970. It has brick veneer cladding and a flat roof. Four historic window openings divide the elevation into four bays. One historic multi-light wood window remains in place indicating the historic configuration of the original windows. The remaining three window openings have been reduced in size, infilled with plywood sheets, and new 1/1 vinyl windows fill the space. A historic metal awning extends across the first floor storefront. A new residential pedestrian door accesses the second story and replaced an historic glazed wood door. The first floor retains a recessed central entrance storefront with aluminum display windows flanking a glazed wood entry door. Glazed enamel panels or Carrara glass formerly clad the storefront area and date a renovation from the 1950s. Some of these panels are missing. The building is identified as a contributing resource to the National Register historic district.

During the site visit there was a significant amount of condensation on the interior of the storefront windows. These should be evaluated to make sure the seals are not broken and they are weather tight. If a customer cannot see into the business because of fogged windows, they will be less likely to enter. As the storefront is the primary pedestrian interaction with the building, a unified and consistent appearance is important.

The exposed brick north wall should be evaluated by structural engineer. Identify any active issues such as water infiltration from the roof, clogged roof drains, inappropriate sloping toward the wall, etc. and repair. Consider covering the damaged brick with stucco (DryVit) or metal paneling to protect the damaged material and preserve the building.

The historic storefront provides a sheltered and welcoming entry to the building. The historic metal canopy should be retained. Repair to the canopy skirting could include new sheet metal to finish the edge and/or paint to unify the appearance of the canopy. Repair decking of the canopy to stabilize the structure and ensure weather tight for the pedestrians underneath. Integrity of the canopy chains should be verified and the chains repainted glossy black color to enhance the existing appearance. The open recessed entry should be retained.

To continue to unify the storefront area salvaged Carrara glass panels could be obtained to replace the missing pieces on the storefront bulkhead. If the actual panels cannot be acquired, then a glossy black enamel paint in the areas where the glass is missing will help to diminish the appearance of the blank areas.

Windows at the second level should be removed and replaced with windows to closely match the original window. One original window remains and can be used as an example to mimic the configuration of additional new windows. The configuration of the windows is somewhat unique with a four-pane transom and vertically divided (rather than horizontally

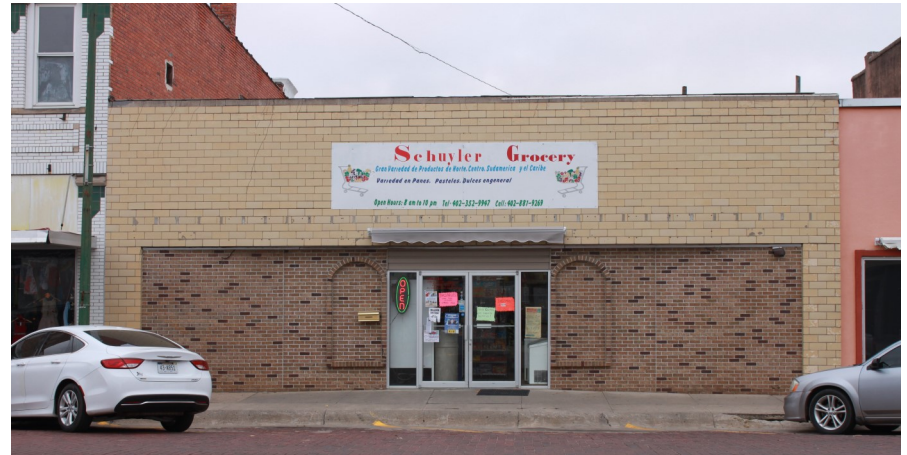
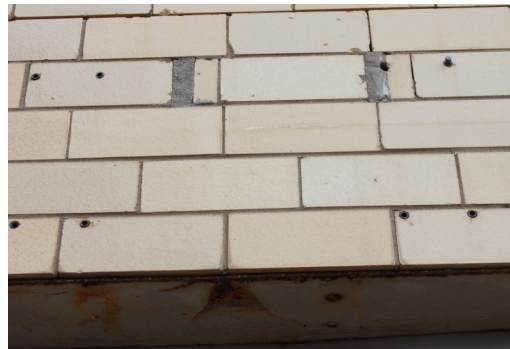
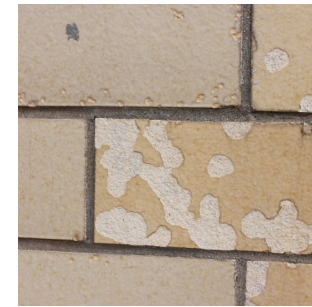
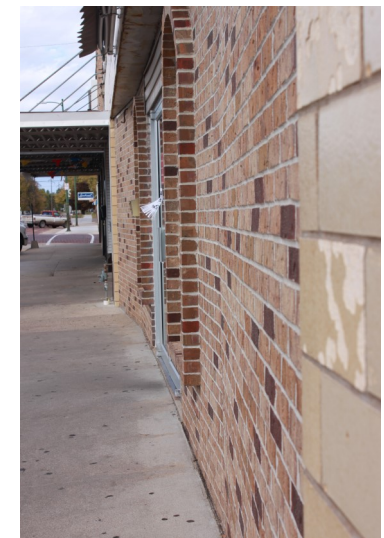
This one-story commercial bay has a flat roof with glazed block cladding the upper portion of the façade. Brick veneer infilled walls (of the former storefront area) flank paired glazed aluminum pedestrian doors with aluminum sidelights. Rectangular panels with arched tops flank either side of the entry doors. The building is identified as a non-contributing resource to the Downtown Schuyler Historic District.

A printed vinyl banner sign has been attached to the façade above the entry doors. Ghosting on the glazed tile above the storefront area is evident where a former full-width canopy extended across the façade.

Maintenance issues that may be causing damage to the façade should be evaluated and identified. These include bad or clogged roof drains, leaking roof, inappropriate sloping to the parapet walls and climate control systems. Once any needed repairs or active water infiltration has been identified and addressed, the glazed tile should be repaired. A Preservation Brief created by the National Park Service offers detailed process to repair the damaged tile at the façade. Additionally, any mortar that needs repair or is missing should be re-pointed, following the Preservation Briefs.

Because this is a simple and unadorned façade, returning the metal canopy across the main elevation is recommended. Not only will this shelter some of the non-historic brick infill, but it will also provide shade and comfort to the customers. A canopy will unify the storefront and offer a distinct and defined area for the storefront.

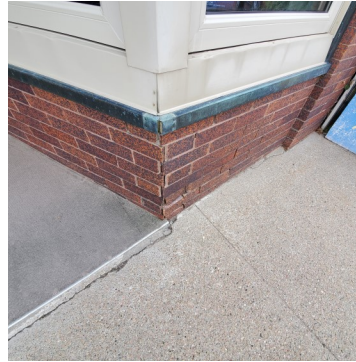
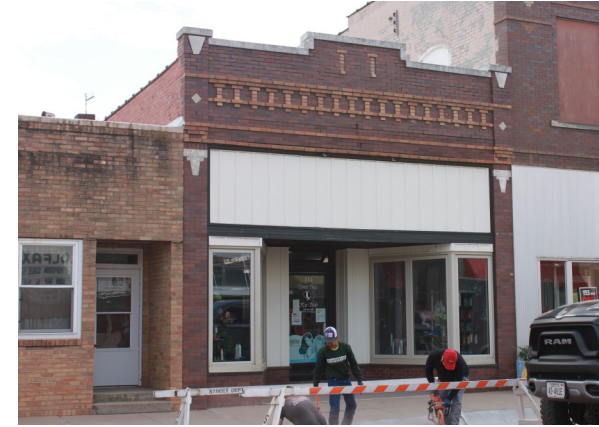
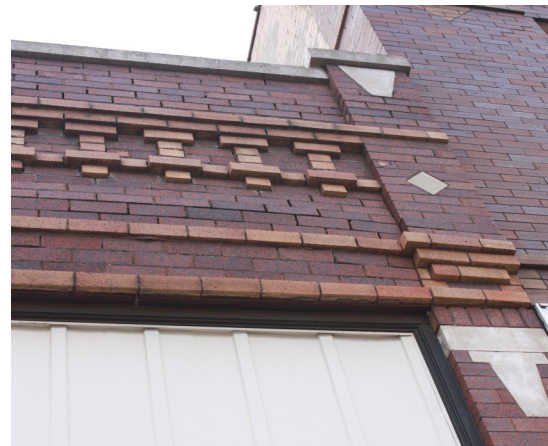
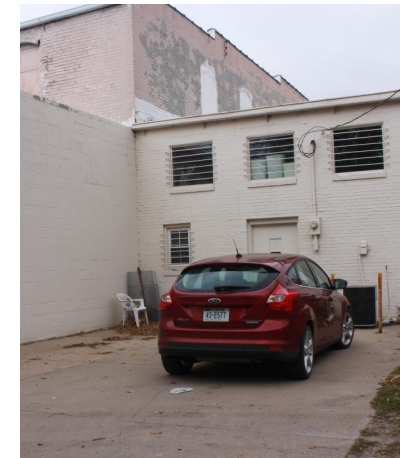
This one-story brick commercial block has a stepped parapet ornamented with stone and yellow dentillated bricks cap the building. The original deeply recessed storefront opening fills the primary (north) façade.

There is a significant slope from the entry door to the sidewalk and original historic tile remains under the carpet.

Non-historic aluminum display windows fill the space within the original copper storefront window frame.

The main entry is an aluminum glazed door with transom and sidelights. The transom area has been infilled with vinyl clad or steel sheeting. The small brick façade is highly ornamented with raised brick and stone detailing.

The ornamented façade appears to have some drainage issues as much of the mortar is deteriorated or missing and the parapet wall appears to be bowing. A structural engineer/architect should be consulted to identify any structural issues and assess drainage or water infiltration into the parapet wall. Once the source of the damage has been identified, it should be remedied prior to any other work on the building. A Preservation Brief is provided that identifies methods used for this process.

The transom window above the storefront could be an asset to the business and provide additional natural light into the commercial space. Investigate what is behind the sheeting cover the transom and if the transom could be replaced. If transom is in place, any missing glass pieces should be repaired, replaced and transom re-opened. If the covering is left in place, it could be painted a color that more closely matches the façade. A new fabric awning could extend across the façade in bold colors that match the corporate identity of the tenant. Black and white stripe awning installed over the enclosed transom area would shelter the sheeting covering the transom. In this case the transom infill would remain in place. Reconsider if the transom is opened and repaired/restored.

Original multi-color mosaic tile flooring remains in-tact under the carpet within the recessed entryway. The carpet should be removed, the tile repaired and left in place. Replace and/or repair any missing tiles, re-grout if necessary and leave exposed. A runner type removable carpet should be added if the floor becomes slippery in wet/cold environment. Consult the Preservation Brief on tile floors provided in the resource section at the back of this report.
