NEBRASKA MAIN STREET NETWORK
DESIGN CASE STUDY

NELIGH FAMILY DENTISTRY

Neligh, Nebraska

BUILDING FAÇADE/FEATURES ASSESSMENT

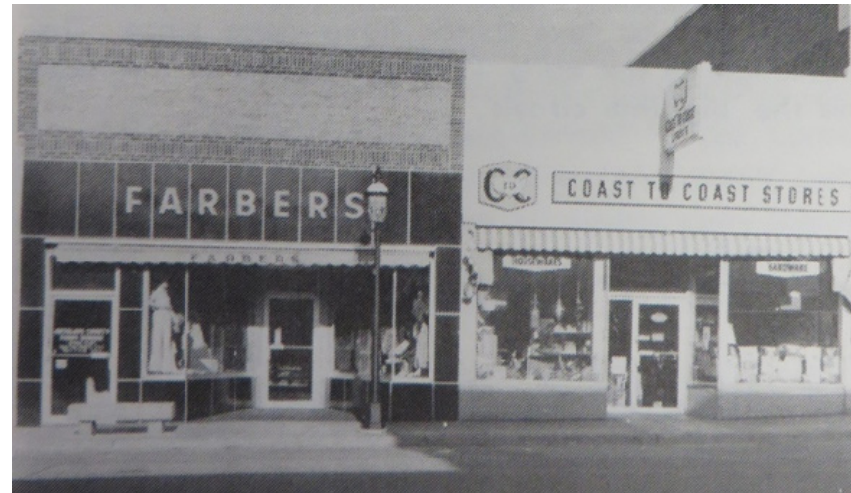
STOREFRONT

The paneled system on the storefront is not original, but has been in place for a substantial period of the history of the building (*image at upper right: storefront showing the composite panel system*).

- The panels are delaminating and are in fair condition. It is recommended that a portion of the panel system is removed for evaluation of the condition and materials under the plywood. It can be assumed that the walls behind the plywood are brick. Then determine whether the brick is in good enough condition to be exposed.

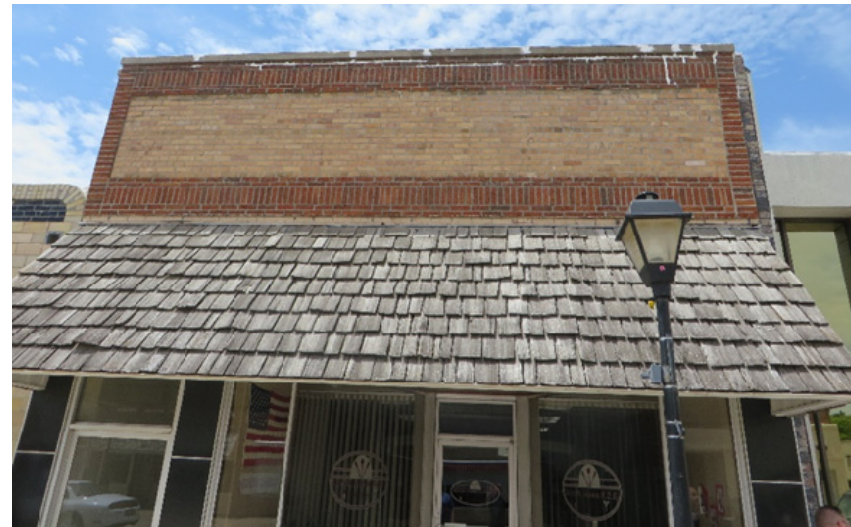
WALL

Above the storefront, the wall is yellow brick, framed in red brick original to the construction of the building. The brick is on good condition but the mortar is deteriorating. There have been obvious attempts in the past to patch the mortar with caulking (*image at lower right: brickwork of the wall above the storefront*).

- The brick wall should be completely tuckpointed.

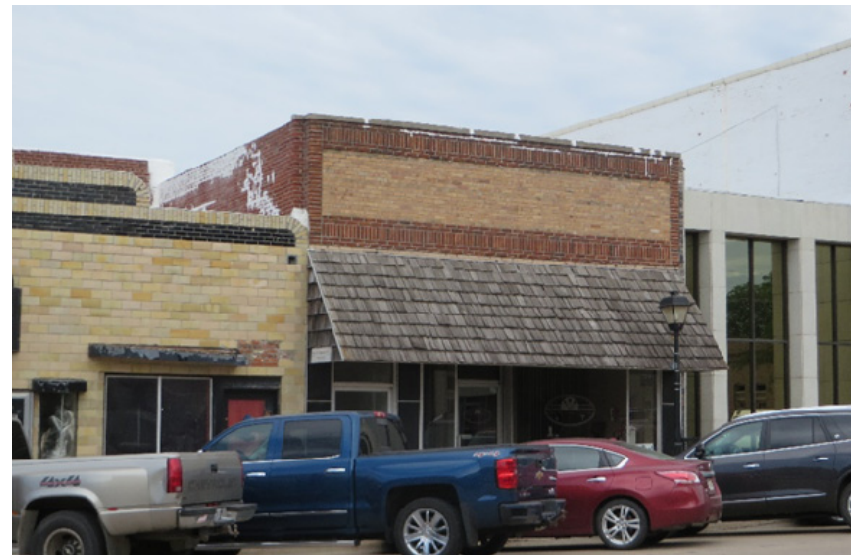
SIGNAGE

The existing sign is small and not noticeable by traffic.

- The sign should be removed from this location and be a part of the awning, a projecting sign above the awning, or professionally designed laser cut vinyl on the storefront glass.

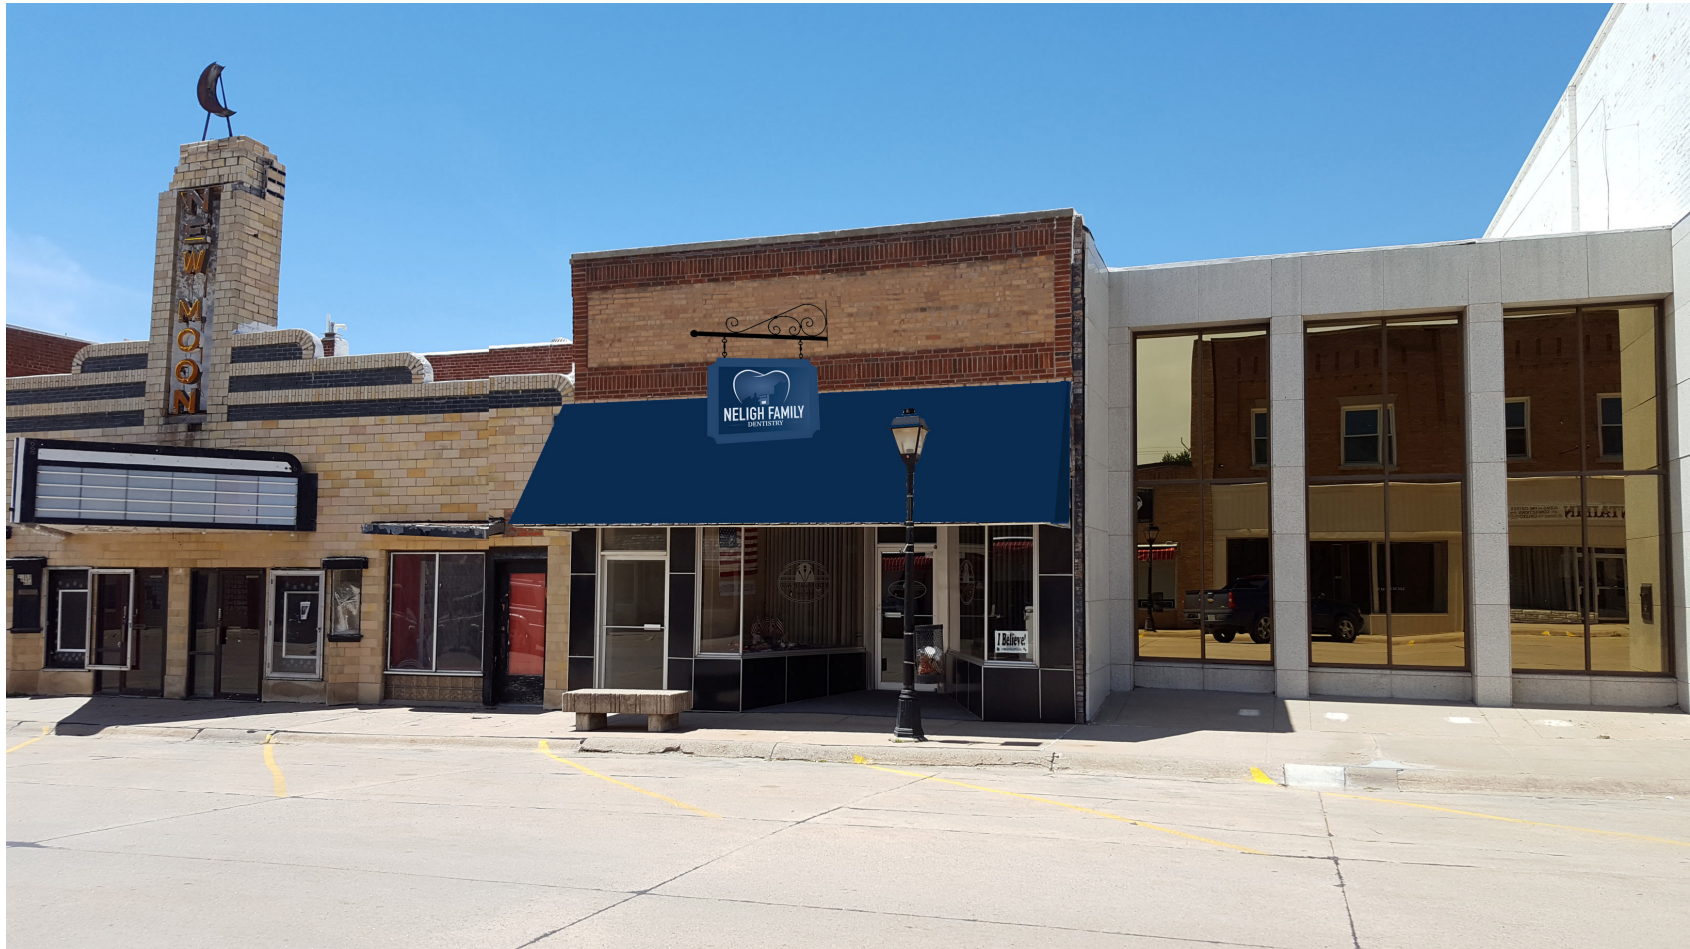
RECOMMENDATIONS ILLUSTRATED

Façade illustration showing façade with a fixed canvas awning and projecting sign version 2 (blue)
