Photography Connie Swanson 209 West 3rd Street Grand Island, NE 68801 Connie **Lied Main Street**

These photographs show the existing condition of the Connie Swanson Photography building. The property owner would like to restore the building's facade as closely as possible to the historic original. Building improvements are to include the removal of the metal false facade, restoration to the degree needed, and installation of signage and lighting.

Project Code: **GRI0701** 3 July 2007

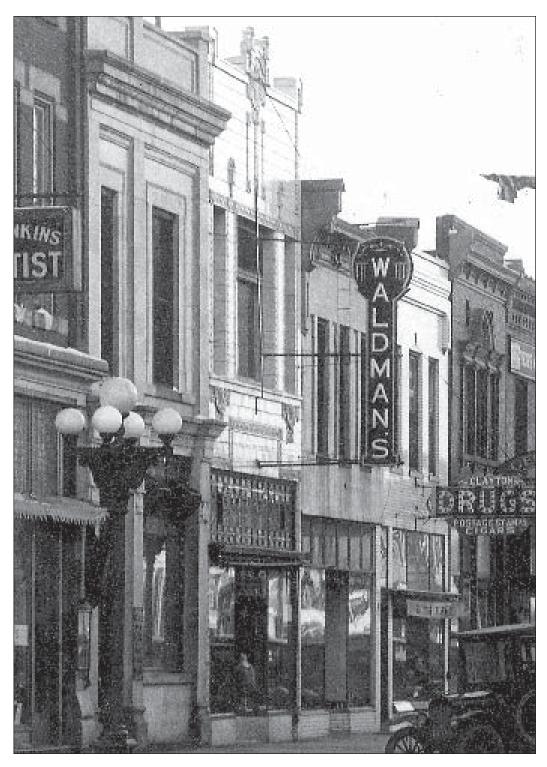
Image 1: Historical Photograph. In this early photograph of the present Connie Swanson Photography building, all parts of the original façade including second story windows; terra-cotta coping, cornice, sills, and accent pieces; full-width transom window; and storefront windows—are intact. The building is shown to have been a Waldman's store.

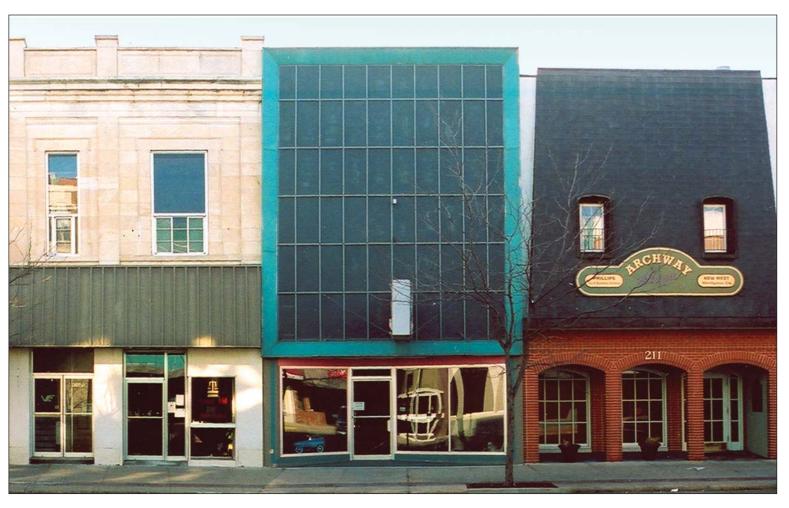
Image 3: Existing Condition. In the mid-1960s, a substantial plywood and metal false front was installed over the upper portion of the building facade. Portions of the lower facade were covered with one-inch-square ceramic tiles. Because the false front remains entirely intact, the condition of the original facade is unknown. The large second story windows are still in place and appear, from inspection after removal of an interior wall on the second floor, to be in fair condition. The original leaded glass transom window at the first floor storefront and the building's terra-cotta cornice have been removed.

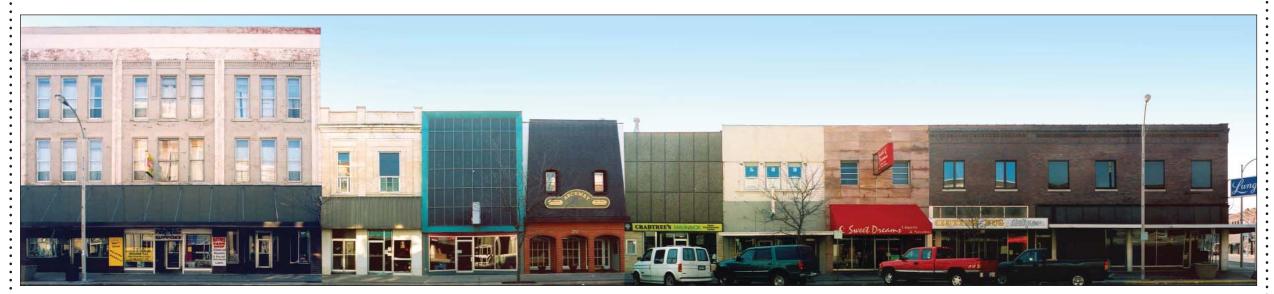
Image 4: Existing Condition. The Connie Swanson Photography building is located near the midpoint of the 200 block of West 3rd Street, adjacent to the Archway building to the west. The building faces north.

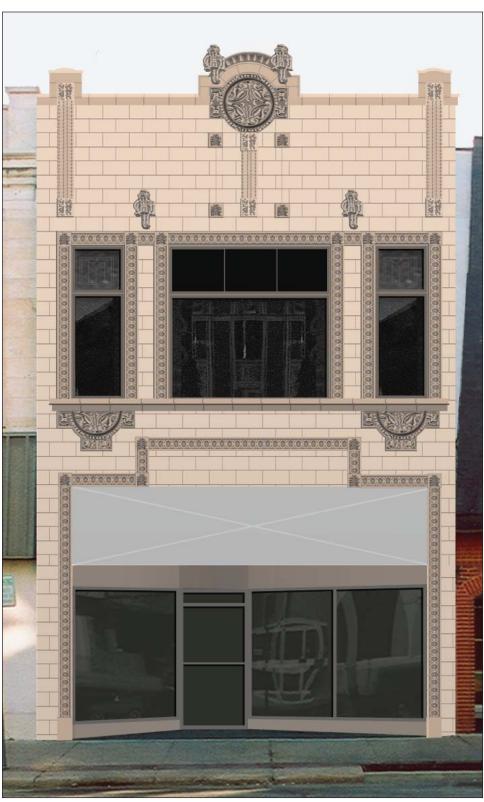
Image 5: Facade Reproduction. This view represents what the building probably looked like before the addition of the false front in the mid-1960s.

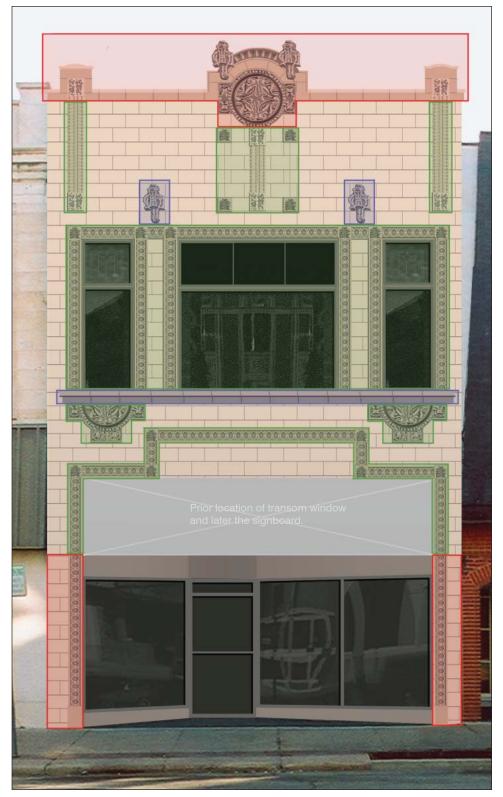
Image 6: Facade Reproduction.

This annotated view explains assumptions made in the production of subsequent drawings.

Note: The condition of the unadorned face terra-cotta units is unknown.

Known to be removed. Assumed to be in fair condition.

Assumed to be in good condition.

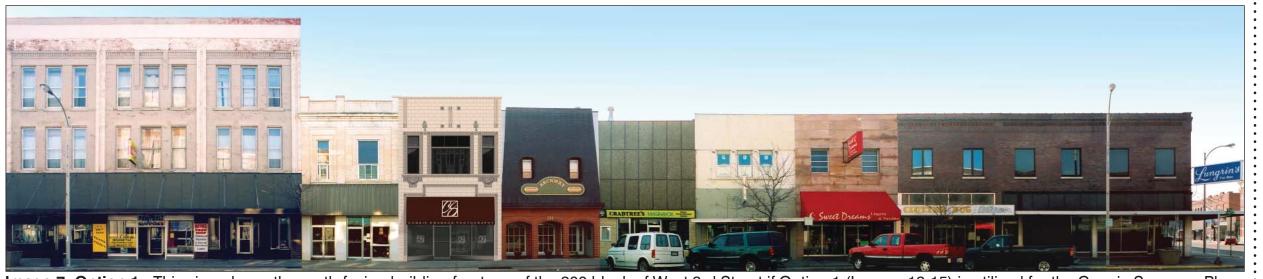
Image 7: Option 1. This view shows the north-facing building frontage of the 200 block of West 3rd Street if Option 1 (Images 13-15) is utilized for the Connie Swanson Photography building.

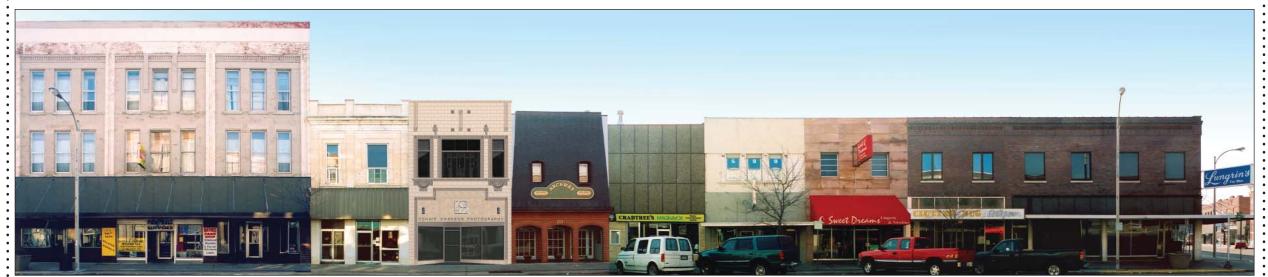
Image 8: Option 2. This view shows the north-facing building frontage of the 200 block of West 3rd Street if Option 2 (Images 18-20) is utilized for the Connie Swanson Photography building.

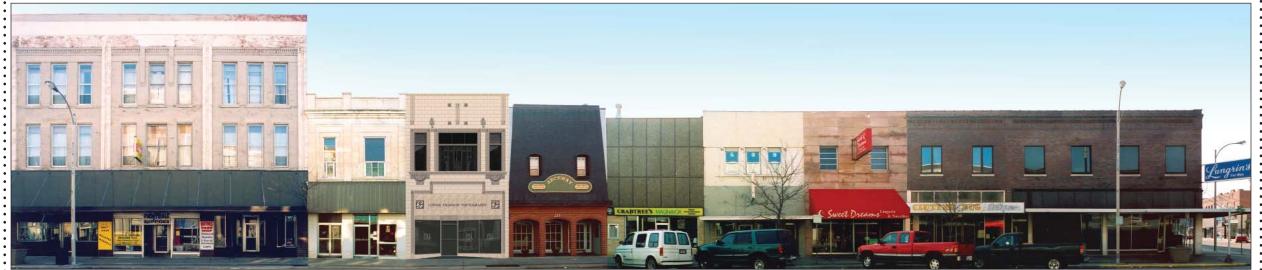
Image 9: Option 3. This view shows the north-facing building frontage of the 200 block of West 3rd Street if Option 3 (Images 21-23) is utilized for the Connie Swanson Photography building.

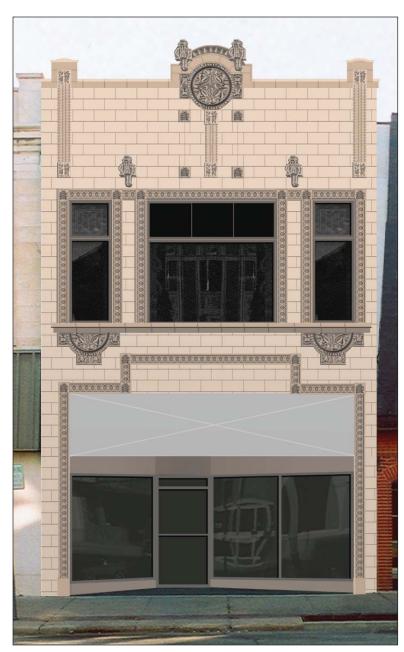
Image 10: Fully Restored Terra-cotta. This view shows the building if the terra-cotta is fully restored. The original cornice has been reproduced and replaced.

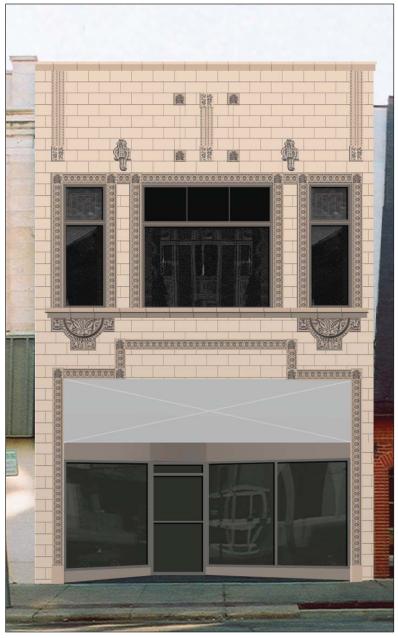
Image 11: Partially Restored Terra-cotta. This view shows the building if the terra-cotta is partially restored. A simplified cornice has been added, while the remainder of the building is restored by replacement of damaged terra-cotta units with reproduction units.

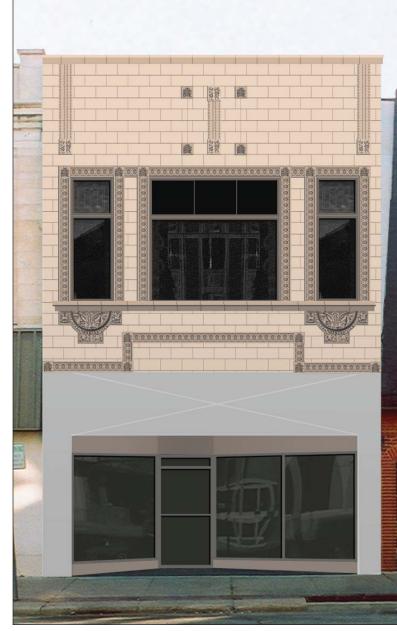
Image 12: Limited Restoration of Terra-cotta. This view shows the building if little restoration of the terracotta is possible. Undamaged terra-cotta is selectively removed from the lower portion of the building and used to replace broken pieces elsewhere on the building facade. A simplified cornice has been added. This view assumes that several terra-cotta sculptural pieces have been damaged.

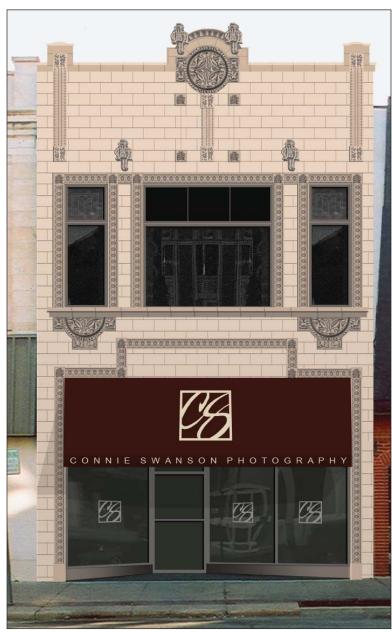
Image 13: Option 1. The former transom window and signboard opening has been covered with an awning fabricated with Sunbrella's "Mahogany" (style 4667) fabric, a sample of which is depicted below. Signage has been applied with graphic film directly onto the awning fabric in Arial font.

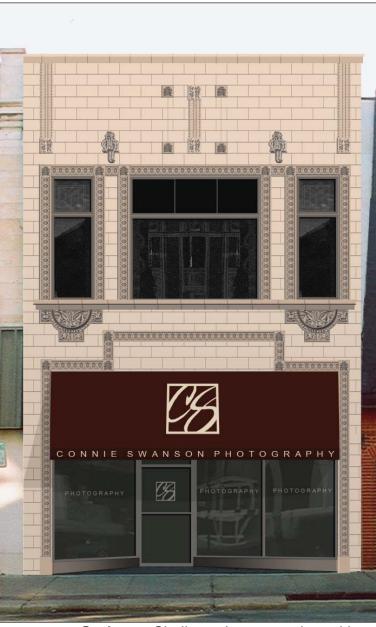
Image 14: Option1. Similar to Image 13, but with simplified cornice.

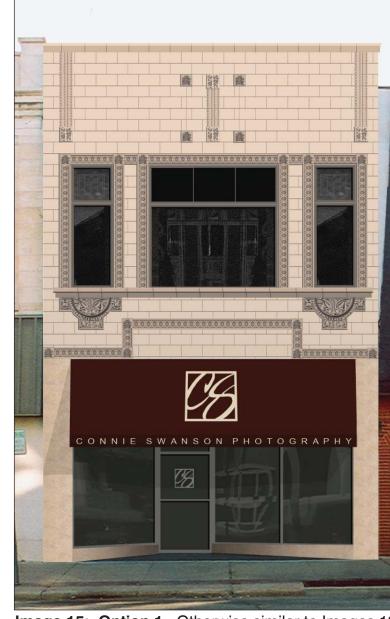
Image 15: Option 1. Otherwise similar to Images 13 and 14, this proposal replaces damaged or lost terracotta units on the lower portion of the building with porcelain tile, a sample of which is depicted in Image 17.

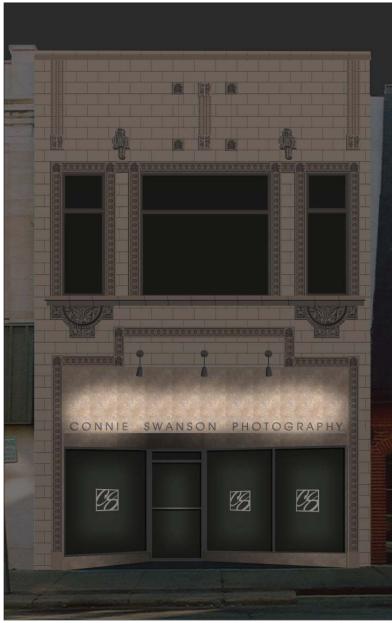
Image 22: Option 3. This proposal suggests flat cut metal in Avant Garde Medium font available from Gemini (http://www.signletters.com) for the signage. SPJ Lighting's Aluminum Sign Lights (SPJ51-05) are used to illuminate the signage.

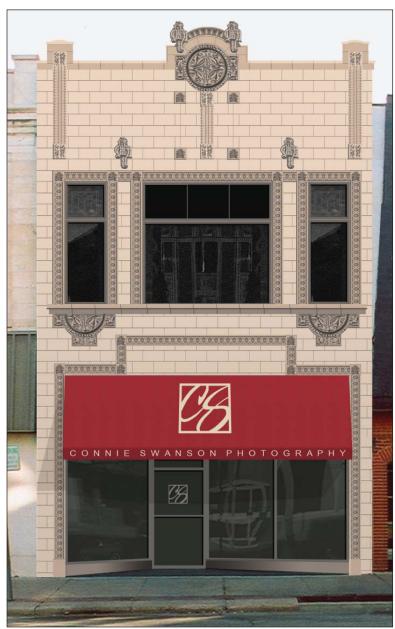
Image 25: Option 4. The former transom window and signboard opening has been covered with an awning fabricated with Sunbrella's "Logo Red" (style 4666) fabric, a sample of which is depicted in image 28. Signage has been applied with graphic film directly onto the awning fabric with Arial font.

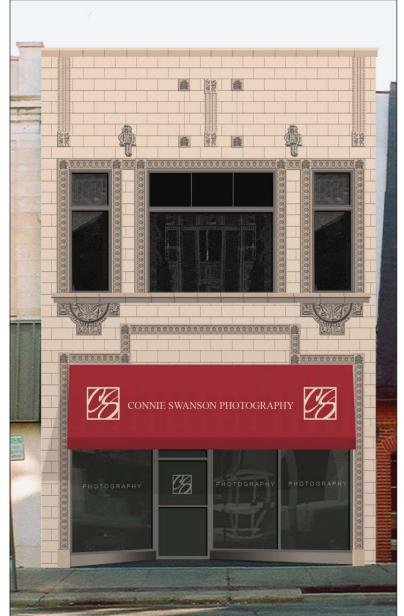
Image 26: Option 4. Otherwise similar to Image 25, this proposal suggests that different signage be applied with graphic film directly onto the awning fabric with Times Roman font.
