# Property

Helleberg 2412 Central Avenue Kearney, NE 68847

Fax: 402.323.7349 **Nebraska Lied Main Street**

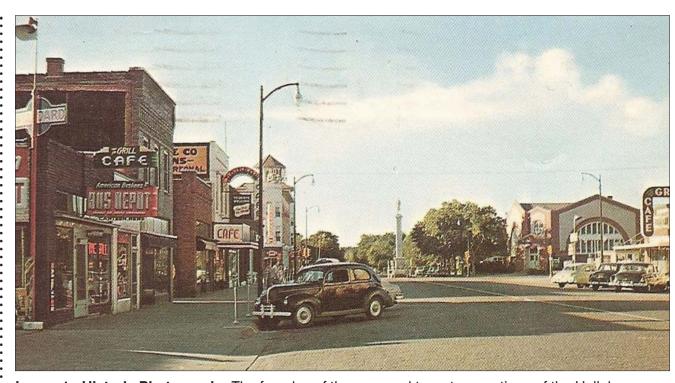
Image 1. Historic Photograph: The facades of the one- and two-story portions of the Helleberg Building are shown at the far left in this historic postcard photograph. A bus depot and a café occupy the one-story portion of the building. Transom windows are evident on both the one-story and twostory portions of the building.

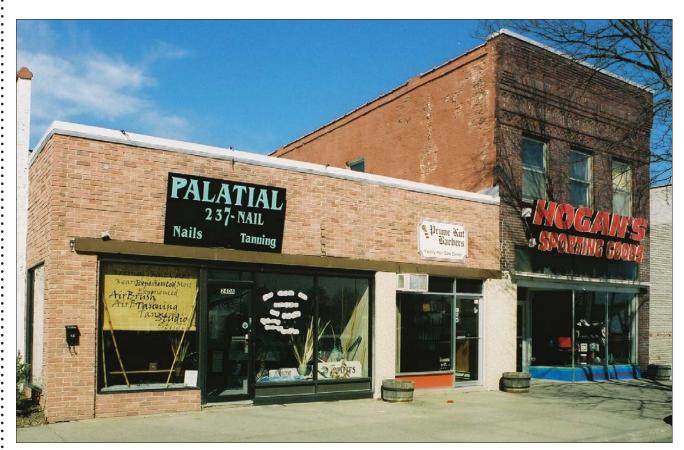
Image 2. Existing Condition: The façade of the one-story portion of the Helleberg Building currently is covered with Z-Brick or some other brand of imitation brick facing. A variety of other surface materials have been applied to the building over the years, and discordant signage now further compromises the original architectural integrity of the façade.

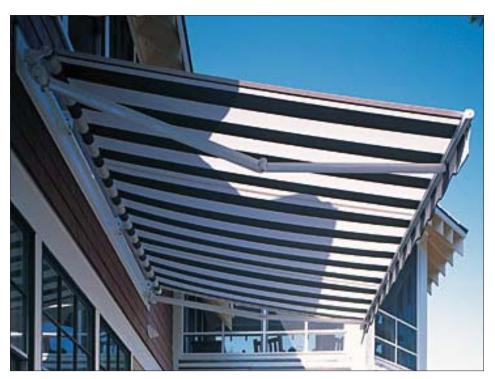
Image 3. Retractable Awning: This example installation of a retractable awning—proposed in the design options presented on the following sheets—illustrates its extended position, as well as its typical mounting condition on the building façade (source: www.sunbrella.com).

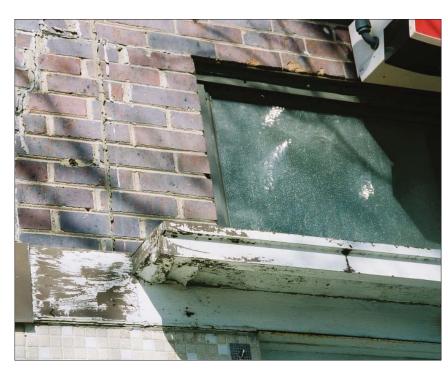
Image 4. Existing Condition: The original transom windows, with textured glass and original metal storefront window frames, still exists on the two-story portion of the building. Presumably, the same type of transom window still exists beneath the Z-Brick or some other brand of imitation brick facing that was installed on the one-story portion of the building. Underneath the transom window is a protruding lip, below which an original retractable awning presumably was mounted.

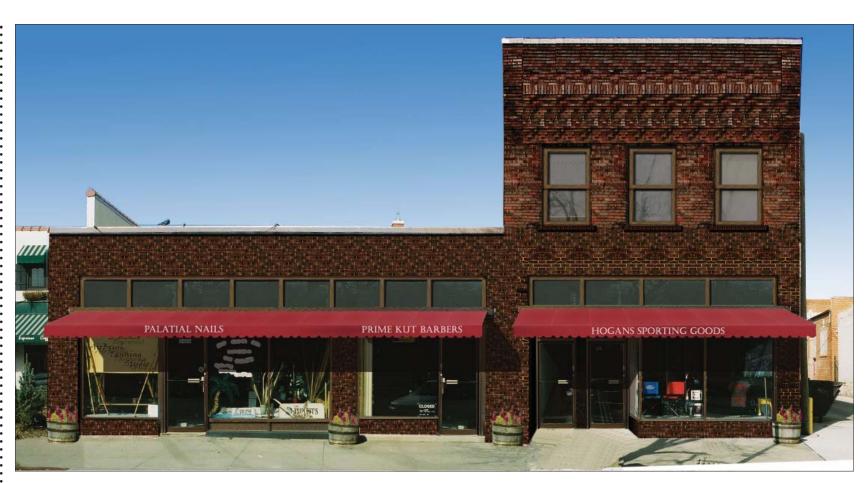
Image 5. Option 1.1: The transom windows on the first floor storefronts are restored, and retractable awnings are installed.

Comments: Options 1.1 through 1.3 depict the use of awnings constructed with the Sunbrella fabric, Logo Red (#4666). The new storefronts and second story windows have bronze-colored metal frames. Option 1.1 shows restoration of the transom windows (with textured or frosted glass similar to the original glass) on the storefronts. Options 1.2 and 1.3 do not necessarily involve restoration of the transom windows. Signage for the stores is appliquéd to the awning valances.

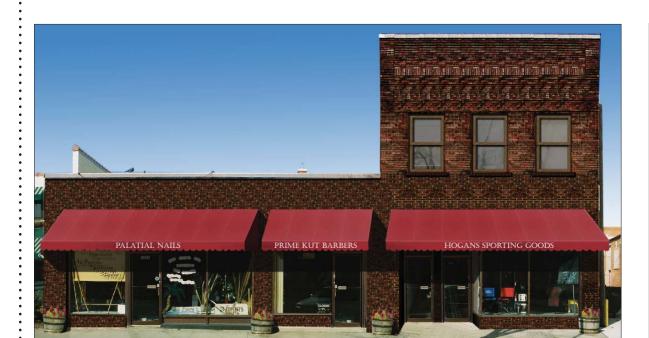
Image 6. Option 1.2: Three conventional fixed awnings are installed on the storefronts to demarcate the three stores in the building.

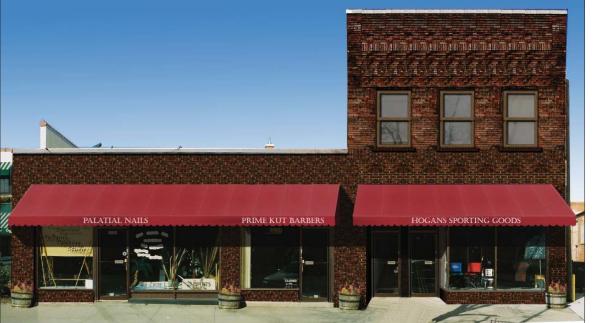
Image 7. Option 1.3: Two conventional fixed awnings are installed on the storefronts, one on the one-story portion of the building, and one on the two-story portion of the building.

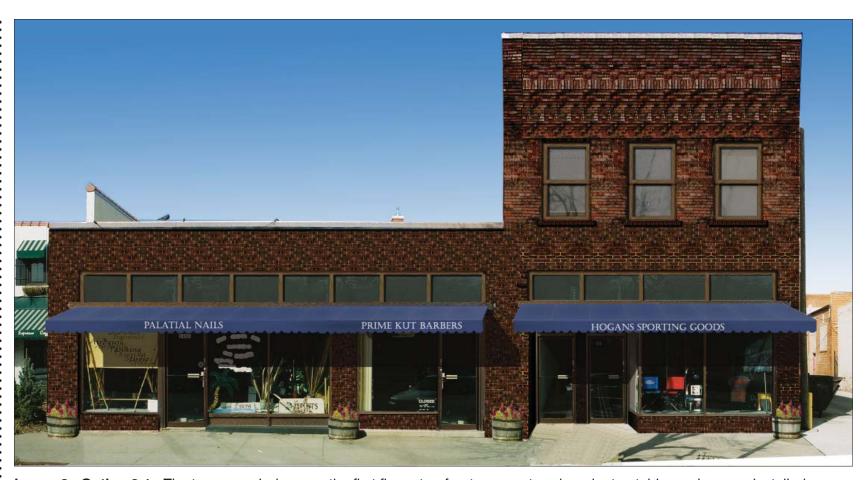
Image 8. Option 2.1: The transom windows on the first floor storefronts are restored, and retractable awnings are installed.

Comments: Options 2.1 through 2.3 depict the use of awnings constructed with the Sunbrella fabric, Mediterranean Blue (#4652). The new storefronts and second story windows have bronze-colored metal frames. Option 2.1 shows restoration of the transom windows (with textured or frosted glass similar to the original glass) on the storefronts. Options 2.2 and 2.3 do not necessarily involve restoration of the transom windows. Signage for the stores is appliquéd to the awning valances.

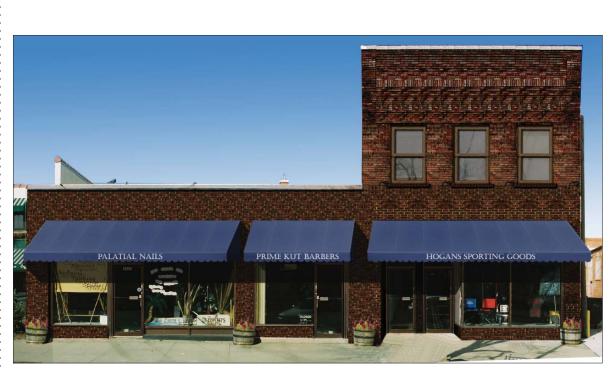
Image 9. Option 2.2: Three conventional fixed awnings are installed on the storefronts to demarcate the three stores in the building.

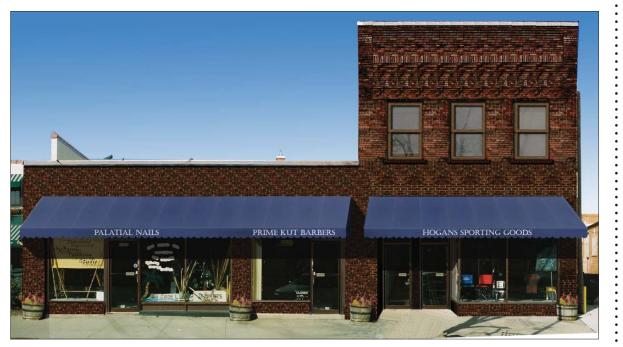
Image 10. Option 2.3: Two conventional fixed awnings are installed on the storefronts, one on the one-story portion of the building, and one on the two-story portion of the building.

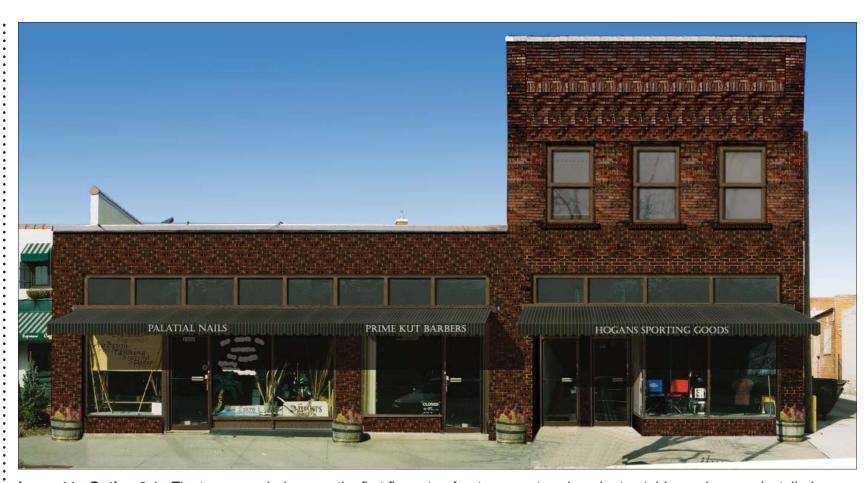
Image11. Option 3.1: The transom windows on the first floor storefronts are restored, and retractable awnings are installed.

Comments: Options 3.1 through 3.3 depict the use of awnings constructed with the Sunbrella fabric. Forest Green Regimental (#4963). The new storefronts and second story windows have bronze-colored metal frames. Option 3.1 shows restoration of the transom windows (with textured or frosted glass similar to the original glass) on the storefronts. Options 3.2 and 3.3 do not necessarily involve restoration of the transom windows. Signage for the stores is appliquéd to the awning valances.

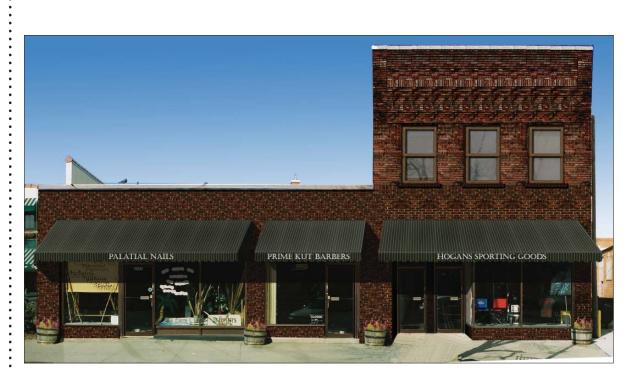
Image 12. Option 3.2: Three conventional fixed awnings are installed on the storefronts to demarcate the three stores in the building.

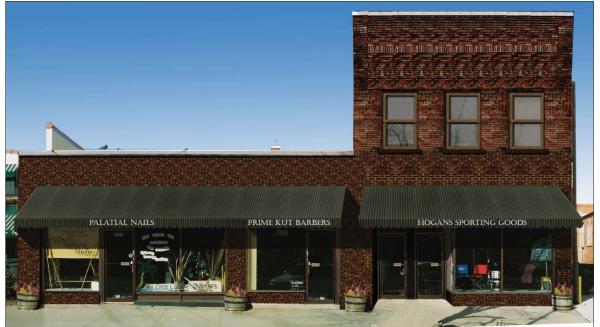
Image 13. Option 3.3: Two conventional fixed awnings are installed on the storefronts, one on the one-story portion of the building, and one on the two-story portion of the building.

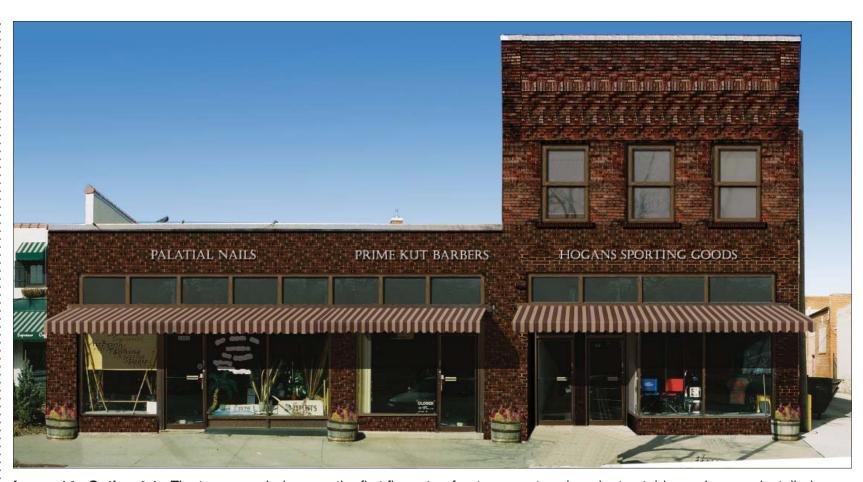
Image 14. Option 4.1: The transom windows on the first floor storefronts are restored, and retractable awnings are installed.

Comments: Options 4.1 through 4.3 depict the use of awnings constructed with the Sunbrella fabric, Brass/Black Cherry Classic (#4939). The new storefronts and second story windows have bronze-colored metal frames. Option 4.1 shows restoration of the transom windows (with textured or frosted glass similar to the original glass) on the storefronts. Options 4.2 and 4.3 do not necessarily involve restoration of the transom windows. Signage for the stores is mounted directly on the building façade.

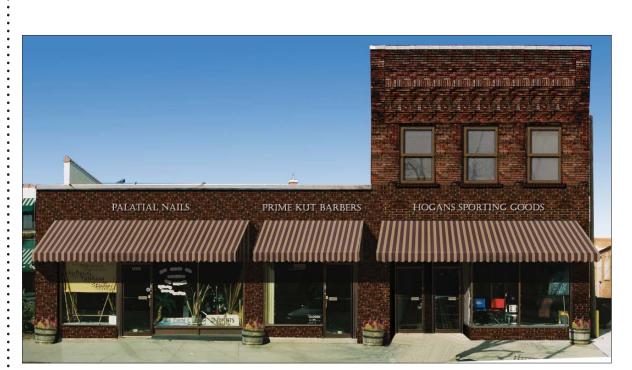
**Image 15. Option 4.2:** Three conventional fixed awnings are installed on the storefronts to demarcate the three stores in the building.

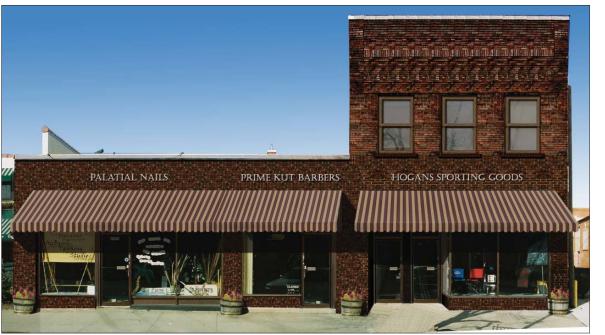
**Image 16. Option 4.3:** Two conventional fixed awnings are installed on the storefronts, one on the one-story portion of the building, and one on the two-story portion of the building.

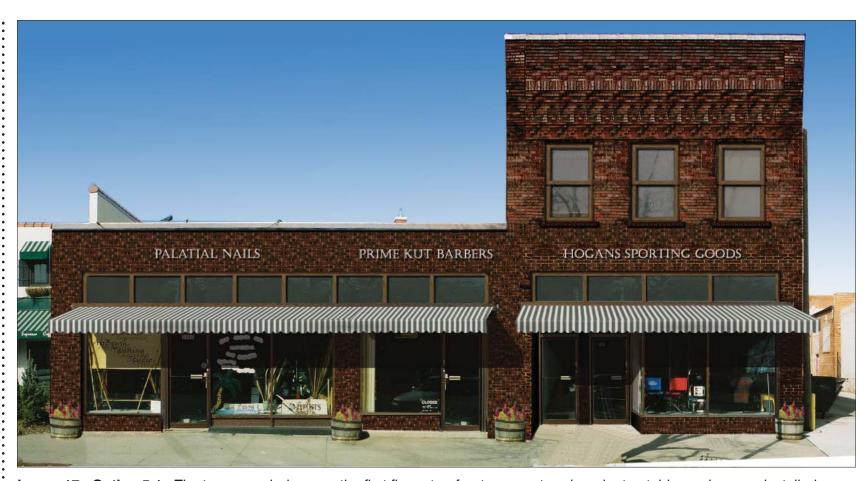
Image 17. Option 5.1: The transom windows on the first floor storefronts are restored, and retractable awnings are installed.

Comments: Options 5.1 through 5.3 depict the use of awnings constructed with the Sunbrella fabric, Forest Green Splash-Spun (#4787). The new storefronts and second story windows have bronze-colored metal frames. Option 5.1 shows restoration of the transom windows (with textured or frosted glass similar to the original glass) on the storefronts. Options 5.2 and 5.3 do not necessarily involve restoration of the transom windows. Signage for the stores is mounted directly on the building façade.

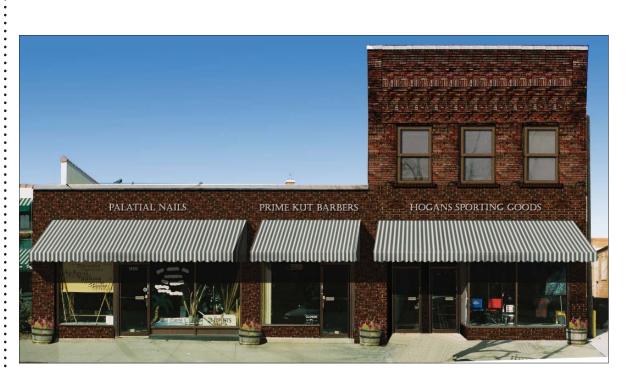
Image 18. Option 5.2: Three conventional fixed awnings are installed on the storefronts to demarcate the three stores in the building.

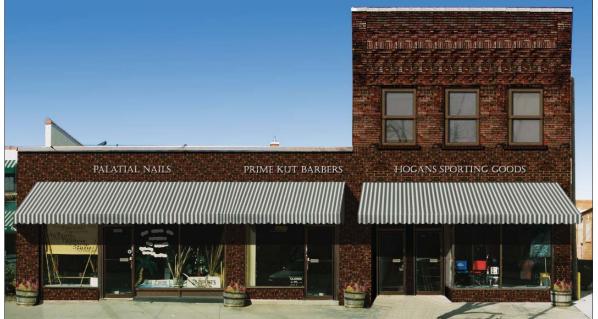
Image 19. Option 5.3: Two conventional fixed awnings are installed on the storefronts, one on the one-story portion of the building, and one on the two-story portion of the building.
