NEBRASKA MAIN STREET NETWORK

# DESIGN CASE STUDY

MOYER'S BUILDING | PITZER DIGITAL

Neligh, Nebraska

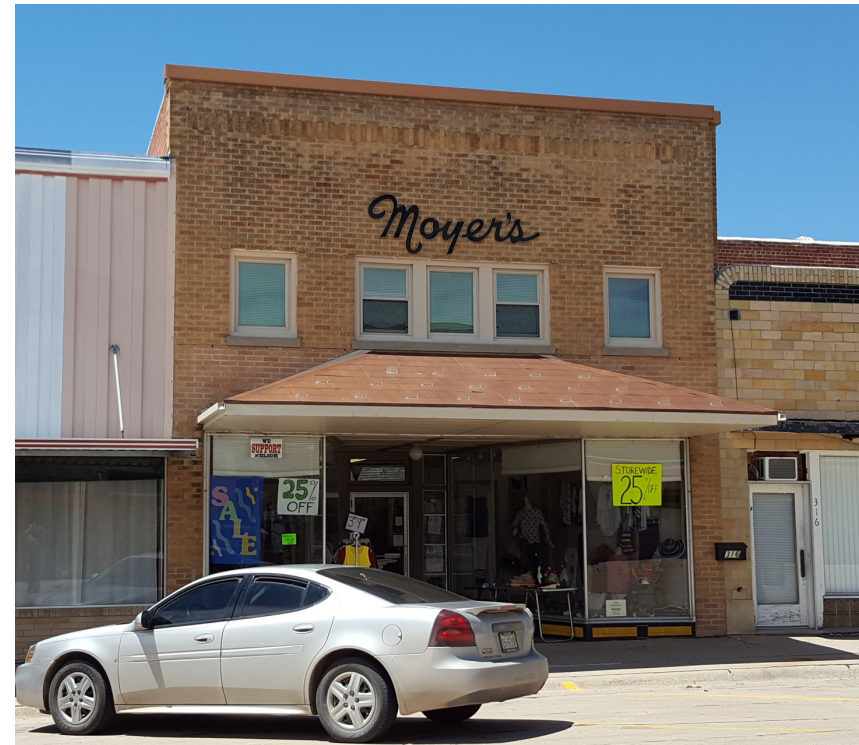
**Condition Evaluation:** FAIR

**Aesthetic Evaluation:** FAIR

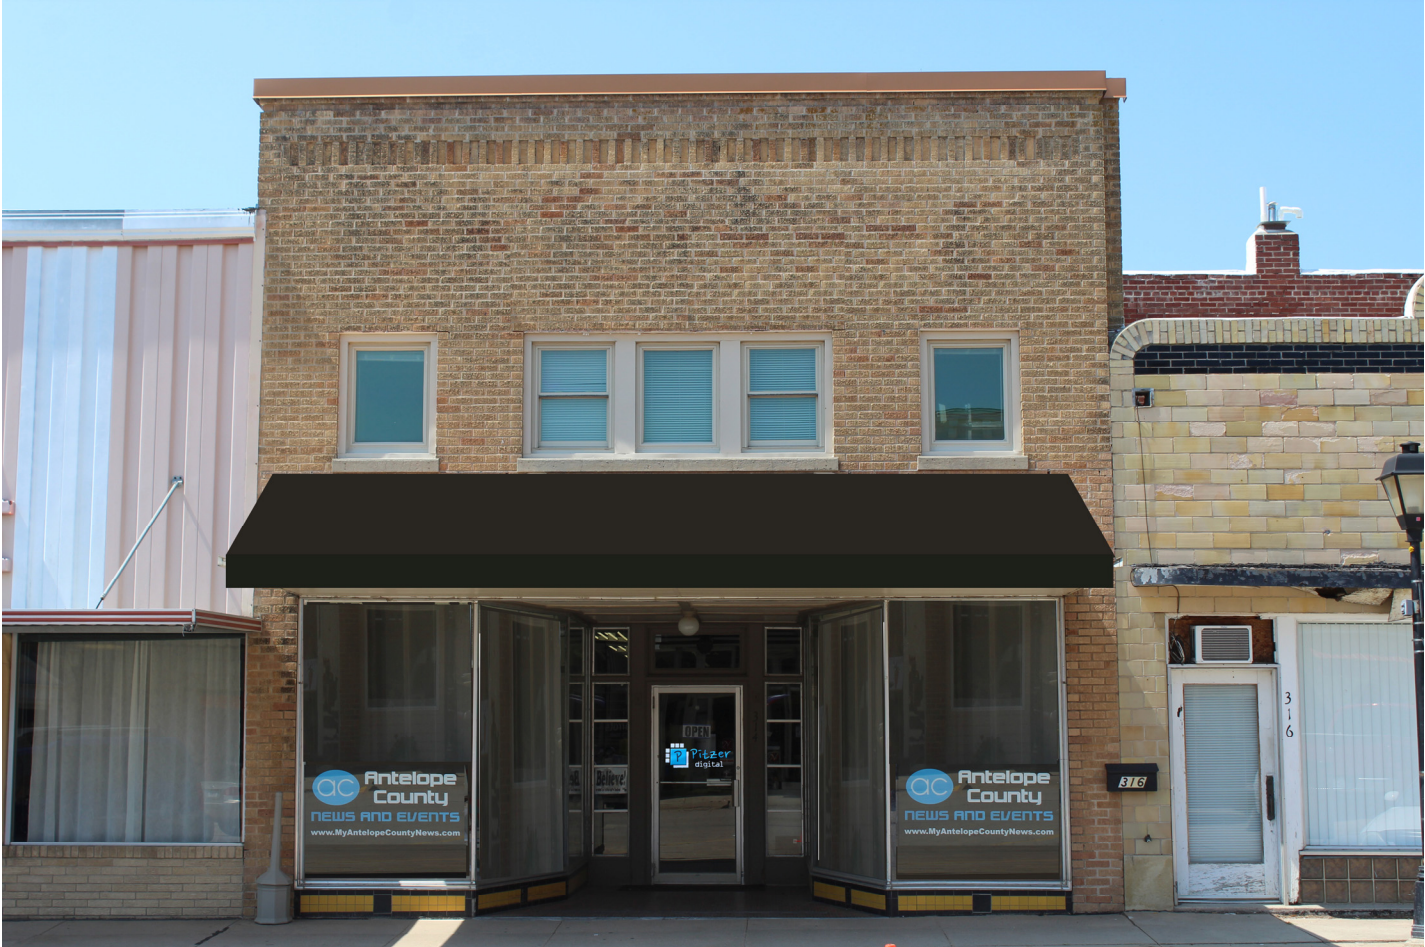
Façade illustration showing façade with a fixed canvas awning and vinyl window graphic signage

- To be period correct and more appropriate to the architecture of the building, the existing awning should be removed in its entirety. A possible replacement would be to install a fixed canvas awning or a retractable canvas awning that would cover the incised diagonal cut in the brick when the canopy is removed.

- The sign should be removed from this location and be a part of the awning and professionally designed laser cut vinyl on the storefront glass.
