Design assistance for:
Majestic Theatre Building
Tom Ziller
 216 West 2nd Street
 Grand Island, NE 68803

Project Code:
GRI0704
 Date:
1 Feb 2008

Sheet No.:
1/1

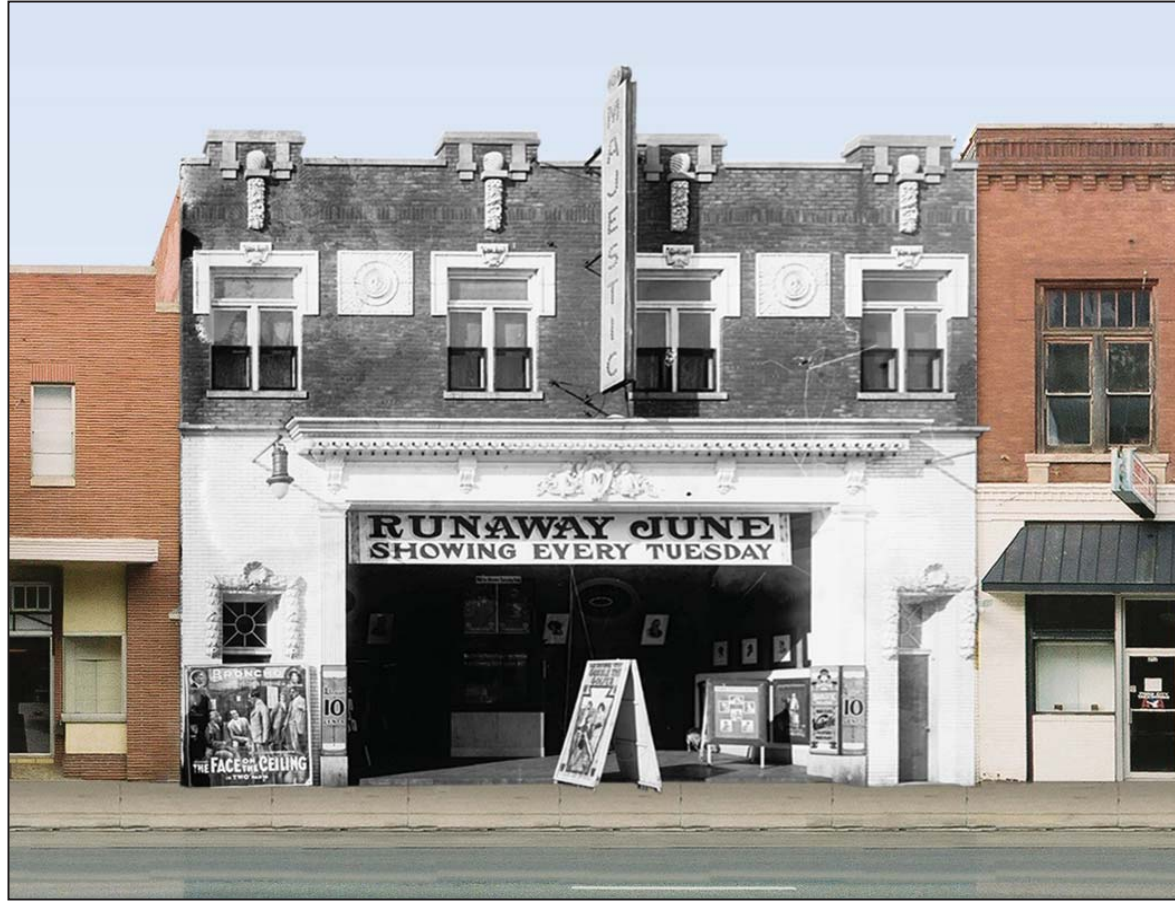
Image 1. Historic/ Present Day Photomontage. A historic 1915 photo of the old Majestic Theatre is superimposed on a photograph of the current block façade. The early photograph of the Majestic Theatre building, including second story window hoods, coping, cornice, medallions, etc., shows extensive terra-cotta ornamentation.

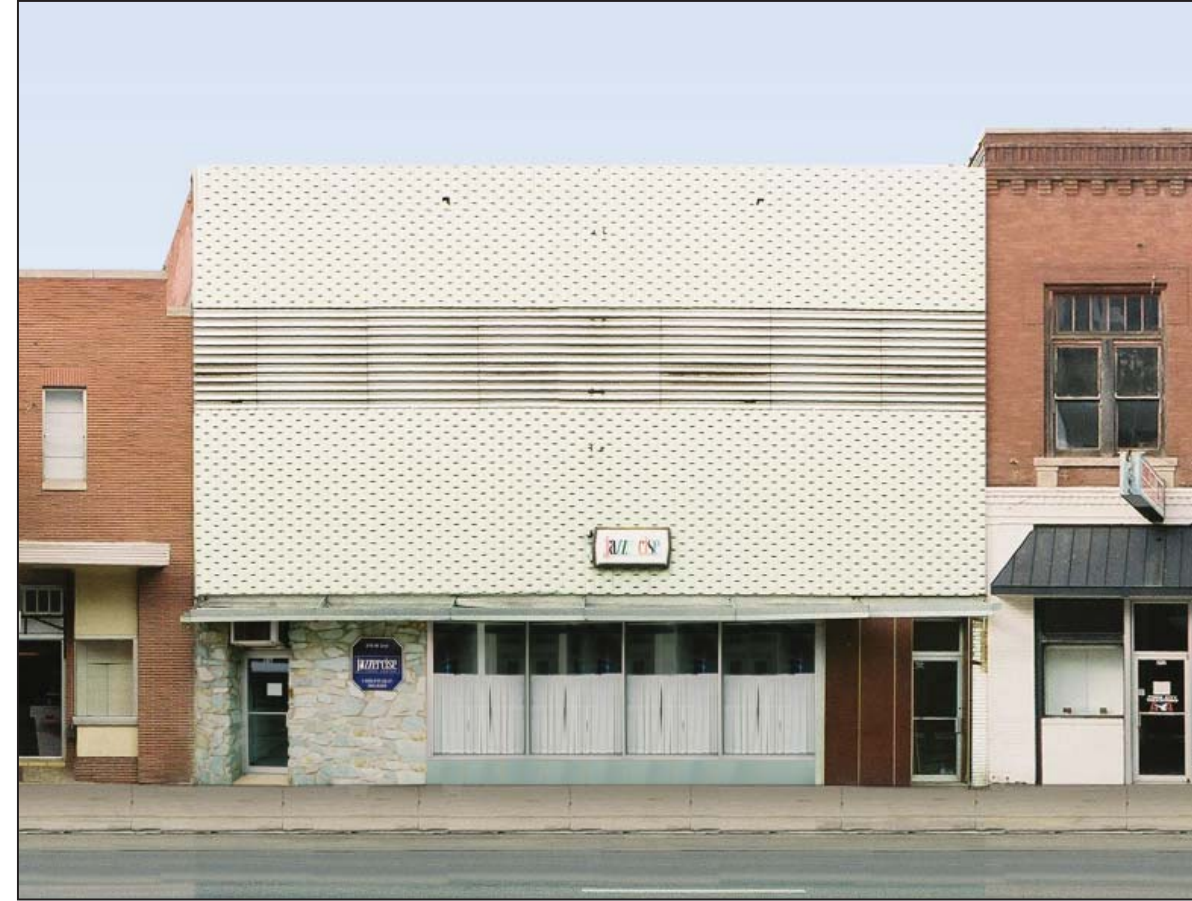
Image 2. Existing Condition. In recent years a metal false front was installed over the upper portion of the Majestic Theatre building façade. The lower façade was reconfigured to address recent building needs. Because the false front remains intact, the condition of the original façade is unknown, although it appears that the decorative vertical extensions of the parapet wall have been removed.

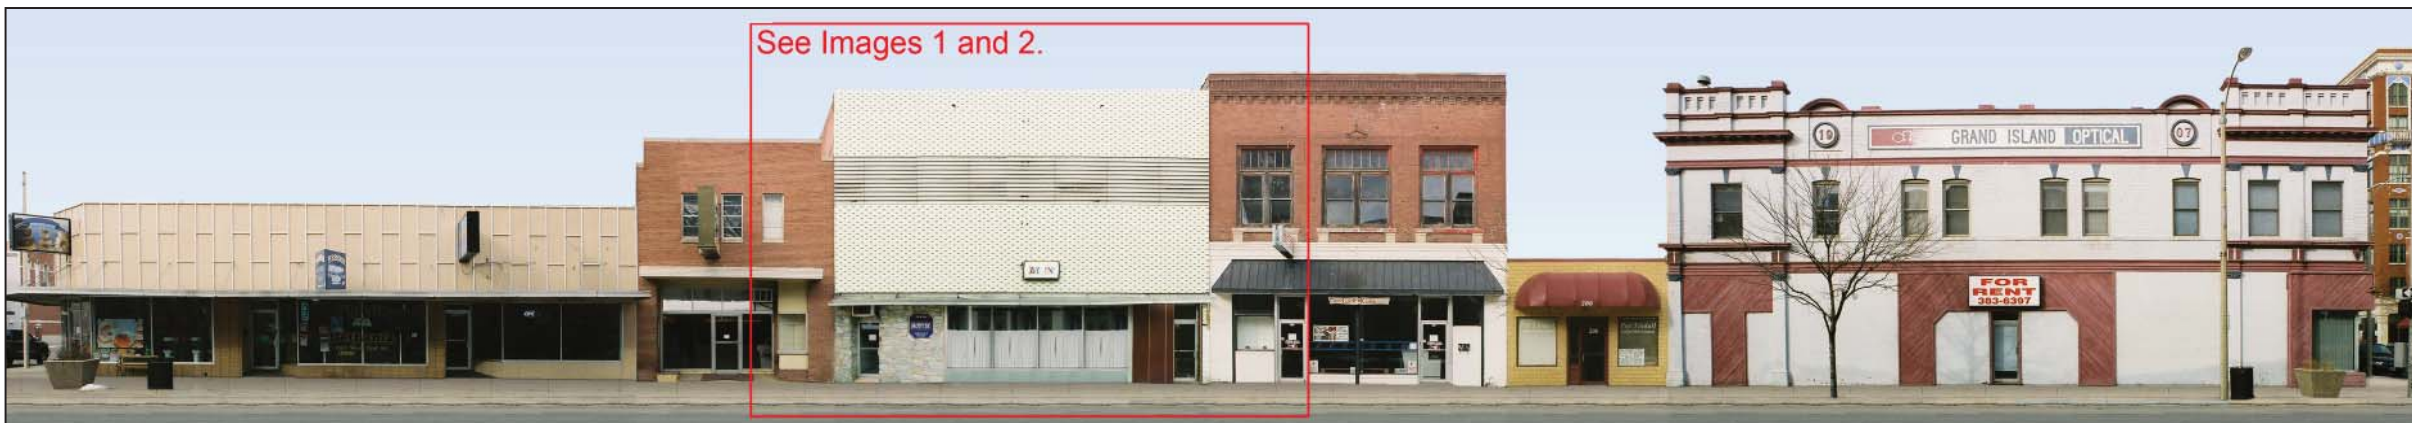
Image 3. Existing Condition. The Majestic Theatre building is located on the north side of the 200 block of West 2nd Street between Bailey Photography and Third City Taekwondo.
